TESTING HIGH-NICKEL ALLOY CASTINGS IN REFINERIES

Refiners today are increasingly dealing with more corrosive feedstocks that present new demands on valves in the process. However, maintenance personnel can detect problems before they become major issues by using different testing methods.

Valve
MAGAZINE

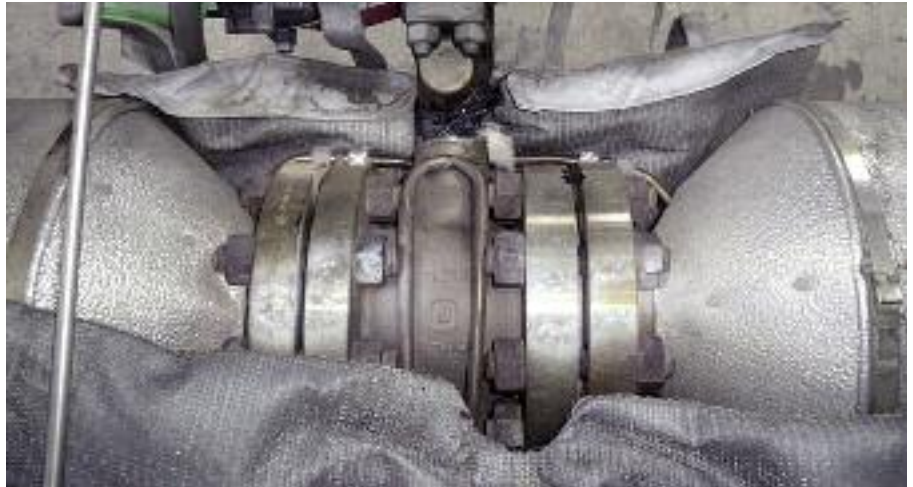
In 2009, a Minnesota-located refinery was experiencing through-wall leakage with several Class 300 rotary valves tasked with controlling crude unit vacuum prefractionator charge heaters. Maintenance personnel removed insulation from the valves and noted coke residue on the surface of the valve bodies, which identified for them where the leaks were occurring (Figure 1).

Figure 1. Removing insulation from around the ball valve in question revealed leakage locations.

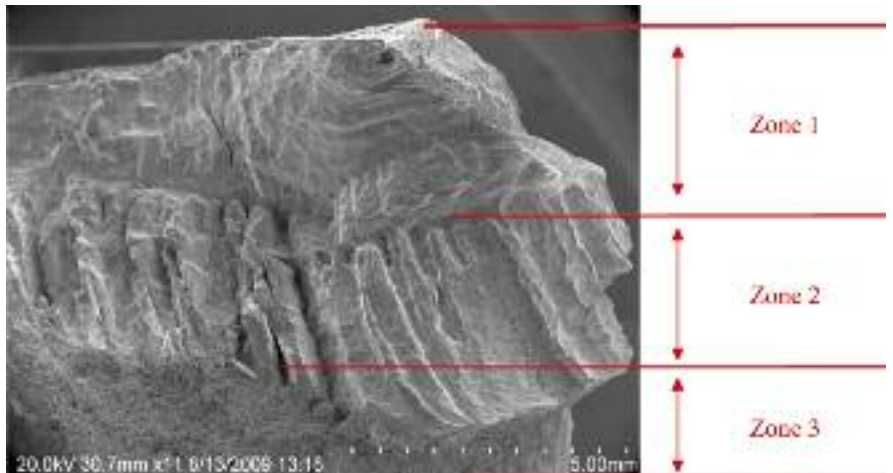
Figure 2. Opened defect showing three zones of fracture. Original magnification 11x.

Fracture surfaces from the neck area of the same valve body were examined using SEM (Figure 2). The first zone examined was an outer layer that was approximately 0.03 to 0.06 inch (0.8 to 1.5 millimeters) thick. This chill layer solidifies rapidly when the molten metal first contacts the mold surface.

The second layer or zone 2 of the fracture has a dendritic pattern. This pattern represents columnar grains that grew perpendicular from the chill layer during the balance of the solidification process. The neck was cast solid so all the grain growth was from the outer diameter to the center. The center of the

Zone 3 was ductile, dimple shear. This is the fracture mode seen on any mechanical break produced in the lab.

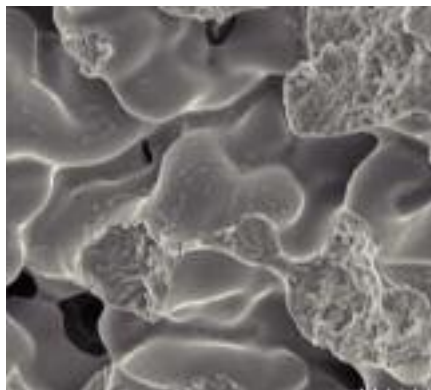
Figure 3. Rounded dendrite fingers indicating a shrinkage defect. Original magnification 600x.

Within the dendritic zone of some of the fractures were rounded dendrite arms (Figure 3). The rounding indicates a shrinkage defect caused by an isolated area of liquid that was frozen off from the riser system because it was not properly fed. When the liquid was consumed during solidification, the dendrite arms could not continue to grow, leaving the blunted tips. Dark areas, which were identified as oxide films formed from exposure to air during casting solidification or heat treatment, were also found on the lab fractures. This proves the fractures were present before the casting went into service.

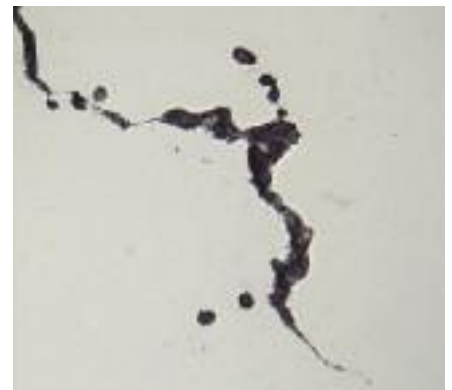
Figure 4. Photomicrograph showing the leak path and the continuation of the grain boundary. Original magnification 500x.

Inclusions and porosity also were visible. The inclusions were mold sand, slag and oxides. The grains were very large compared to wrought product forms—about 1/4 to over 1/2 inch (6 to 13 millimeters). The grain boundaries were the intersection of the dendrites formed during solidification. One leak

path was cross-sectioned (the photomicrograph in Figure 4 shows the continuation along a grain boundary).

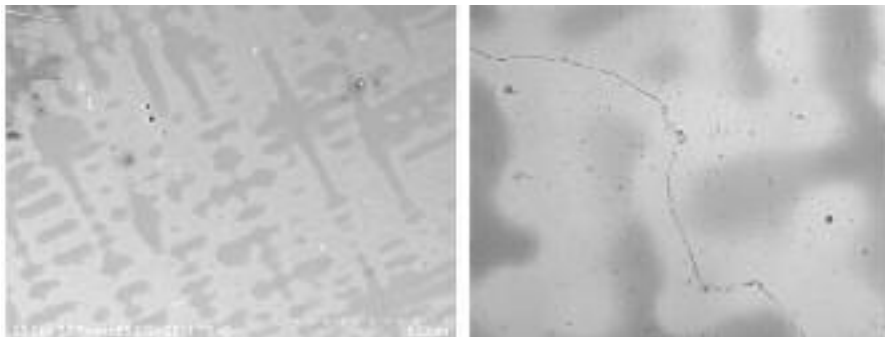
Figure 5. The as-cast microstructure contains elemental segregation and undesirable phases in the interdendritic spaces. Original magnification 85X (left), 500X (right).

In the as-cast condition, segregation and second phases could be seen in the secondary electron SEM image (Figure 5). The heavier average atomic mass produces a lighter image while the lighter average atomic mass produces a darker image. The darker dendritic regions are enriched in the lighter elements, chromium and nickel, while the lighter interdendritic regions contain higher concentrations of the heavier element molybdenum. The second phases are undesirable because of reduced toughness and susceptibility to preferential corrosion attack.

Proper solution heat treatment is required to reduce the segregation and second phases to a minimal level.

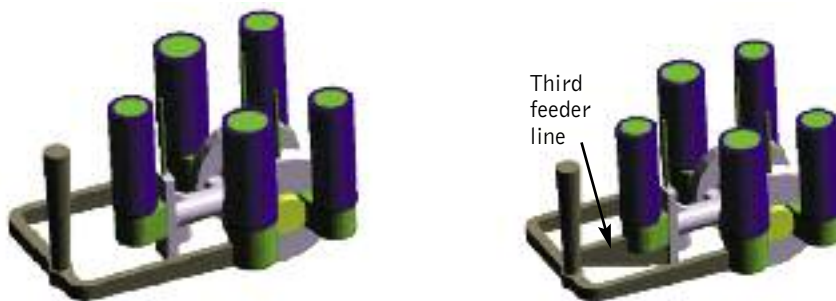
Figure 6. Casting rigging with two-feeder method at left and three-feeder method at right

Analysis of the mold-filling technique used for the original castings revealed a deficiency in the feeding or rigging method. The mold was filled through two feed paths into the flanges (Figures 6 and 7). The lower half of the flanges filled first, then the center section of the body, and finally the neck and foot area.

A high level of turbulence was created as the metal flowed into the neck and foot. The turbulence produced reoxidation of the metal, which introduced oxide defects. The metal was also relatively cold when it reached this area, which created excessive tensile stress in the neck from the highly constrained foot as the solidification progressed back toward the main body.

Casting simulation using a three-feeder system (Figures 6 and 7) demonstrated a less turbulent fill that promoted a desirable directional solidification from the body out towards the foot. This change minimized the highly constrained situation where the foot solidified first.

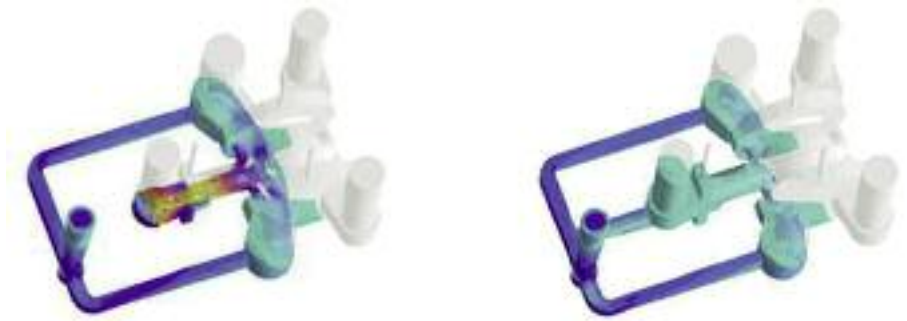
Figure 7. In the two-feeder casting method (left), a high level of turbulence was created as the metal flowed into the neck and foot. The three-feeder casting system resulted in tranquil and low-velocity fill.
