# **Tissue Machine Bearing Failure and PeakVue Problem Resolution**

## Introduction

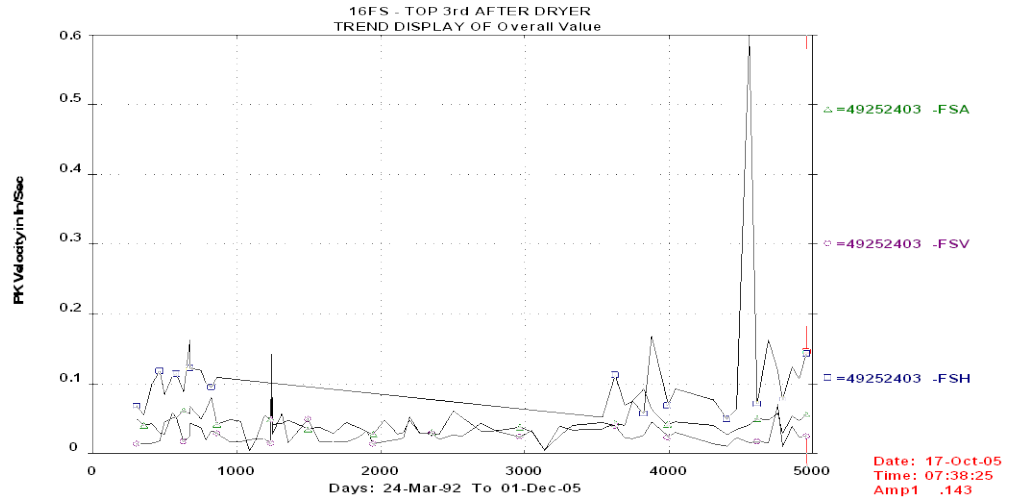
Aside from a minor increase in the axial amplitude, the vibration data from October 17<sup>th</sup> did not show any signs of defect prior to the bearing failure. As a result of the audible noise emanating from the bearing, an inspection was recommended. Shortly after these readings, the T3 bearing failed before a shutdown inspection could be performed. After this failure, PeakVue monitoring was added to the route for all tissue machine rolls.

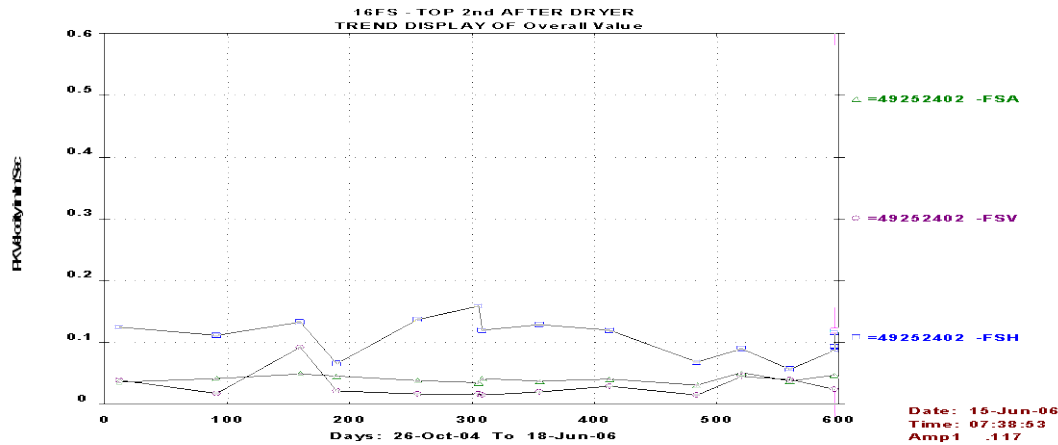
On June 15, 2006, vibration analysis was requested on the 16TM T2 After-dryer tending-side bearing. This was on the same After-dryer section of the tissue machine as the previous failure. An intermittent audible noise was emanating from the F/S T2 bearing. Vibration data was collected on the bearing along with PeakVue readings. Horizontal, vertical and axial vibration amplitudes were low, below 0.12 ips on the bearing housing readings.

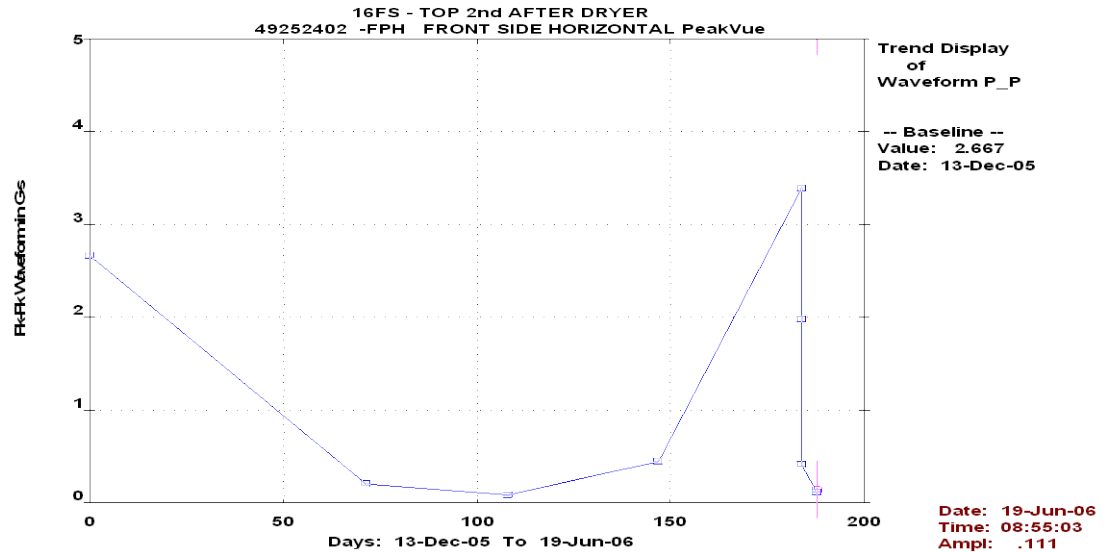
Because of production requirements, the bearing was flooded with oil to maintain TM operation. Readings on June 19, 2006 found that the audible noise and PeakVue values decreased. The problem still exists but

was masked by excessive bearing oil.  
Recommendations to inspect the bearing and perform monitoring until maintenance was possible were reiterated.
