Contamination affects accuracy

John Lansing,

Daniel Industries, Houston, Texas

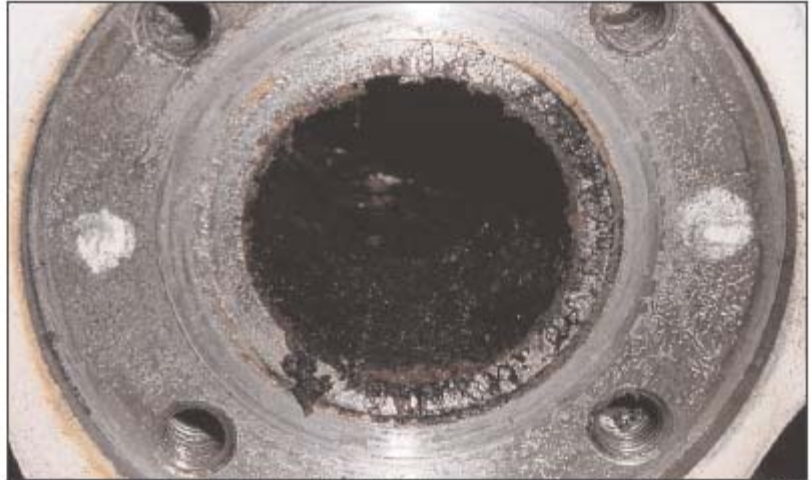
Upon inspection of the transducer ports, there was a very oily, gritty buildup of material.

Upon inspection of the transducer ports, there was a very oily, gritty buildup of material. The transducers were all very clean. The dirtiest one was located closest to the bottom of the meter body, and faced upstream. Since these transducers do not protrude into the stream, their faces remained extremely clean. This is important since any coating on the face will impact the meter’s accuracy’.

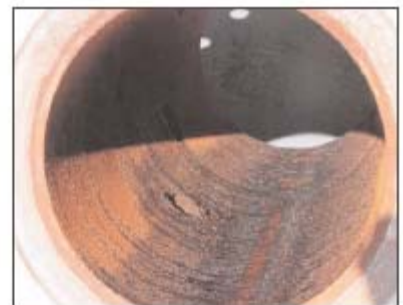
The meter body had a significant buildup of an oily, gritty substance. After careful removal of the fine mill-scale building under this coating, the mill-scale was measured and found to have a thickness of approximately 0.010-in. A surface roughness gauge recorded mill scale readings of 473 μ in. After the mill-scale was removed, the roughness reading of the meter body was 125 μ in. (very close to the original surface finish).

The photo above shows the buildup found on the meter.

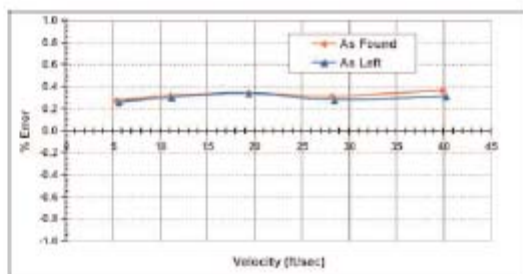
The meter was then removed and disassembled. All meter components, including the flow conditioners, piping spools and transducers, were removed and thoroughly cleaned by the calibration facility. After cleaning, the meter was re-assembled by the lab and tested at similar velocities as before, but a higher velocity point was added. Figure 1 shows a summary of the “as-found” dirty meter and the “as-left” clean test results.

It’s important to remember this ultrasonic meter was not previously calibrated. This explains why the performance was approximately 0.3% fast. This summary shows the result of the “as-found” performance, in red, prior to any cleaning. The blue line shows the “as-left” result. Taking the raw data and determining a Flow Weight Mean Error (FWME), as described by AGA Report No. 9, for the dirty meter would result in a meter factor of 0.9966. After the meter was cleaned, the FWME would have been of 0.9970 (using the same velocity points as for the dirty meter results). The meter factor changed by 0.04% from dirty to clean. That is, the meter reading on average was slightly lower after cleaning.

Unfortunately, there were no measurements taken of the buildup thickness inside the body or associated spools, making it difficult to determine how much the cross-sectional area might have changed from dirty to clean. Judging from the pictures, one can see that this is a dirty meter. In spite of the amount of contamination the meter, flow conditioner, and associated piping had, the meter’s performance was virtually unaffected (approximately 0.04%).

Figure 1. The above table shows why the performance was approximately 0.3% fast.

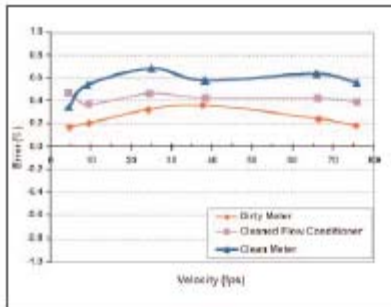
Figure 2 shows three calibration test results for this meter. Included are the "as found" with dirty meter and spools, the results after cleaning only the GFC VAS, and the results after cleaning the entire meter assembly. Note that no components were changed for this test, and the meter's configuration remained the same for all three tests. The meter was returned to Houston, disassembled and cleaned before the final testing was completed.

A simple method to quantify the impact on this meter is to determine a change in the FWME as described in AGA 9. The FWME for the dirty results in Figure 2 is 0.9975; i.e. the meter was reading about 0.25% fast when compared to the CEESI facility. After cleaning only the GFC VAS the meter factor was 0.9959, and after cleaning the meter body, flow conditioner and spools the FWME changed to 0.9939. This equates to an average change in meter performance of 0.16% when only the flow conditioner was cleaned, and 0.36% when the entire meter was cleaned. So, why does this meter's performance go slower instead of faster when dirty?

Figure 2. The above table shows the "as found" with dirty meter and spoons, the results after learning only the GFC VAS, and the results after cleaning the entire meter assembly.

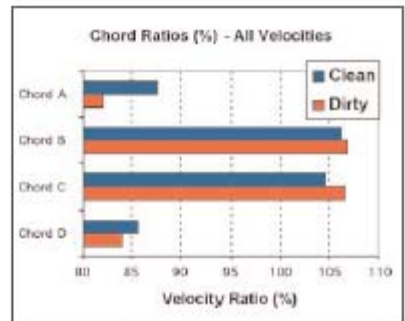
Figures 3 and 4 can be used to help diagnose the meter's data and explain why the meter went faster when cleaned. These graphs represent the velocity ratio, in percentage, of each chord relative to the meter's reported velocity. The red bar graphs in Figure 4 represent the relative percentage of the specific chord relative to the meter's output in the dirty condition and blue for the clean. Notice the two graphs look virtually identical. This means the velocity profile for each chord is relatively independent of gas velocity. Thus, it is not necessary to have a variety of gas velocities, or a proving system, in order to perform this test in the field and determine if the velocity profile has changed. Since users generally collect "start-up" information on the meter, this velocity profile analysis can be used to later help determine if the meter is dirty during regularly scheduled inspections.

Figure 3. This chart can be used to help diagnose the meter's data and explain why the meter went faster when cleaned.

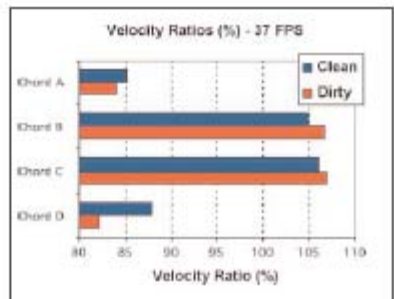
When looking at the chord ratios for B and C, notice the difference between the clean and dirty meter. In both graphs, the dirty velocity

ratio for the center paths is higher than the clean. The A and D outer chord ratios showed a bit more pronounced effect from dirty to clean, but in the opposite direction. These readings were much lower when compared to the meter's average velocity. The surface friction has clearly changed the velocity profile to be more pointed than when the meter was clean.

Figure 4. The red bar graphs represent the relative percentage of the specific chord relative to the meter's output in the dirty condition and blue for the clean.
