Daniel Gas and Liquid Ultrasonic Meters IS Barrier Module Soldering Issue Technical Bulletin

Copyright © 2015. Daniel Measurement and Control, Inc. All rights reserved.

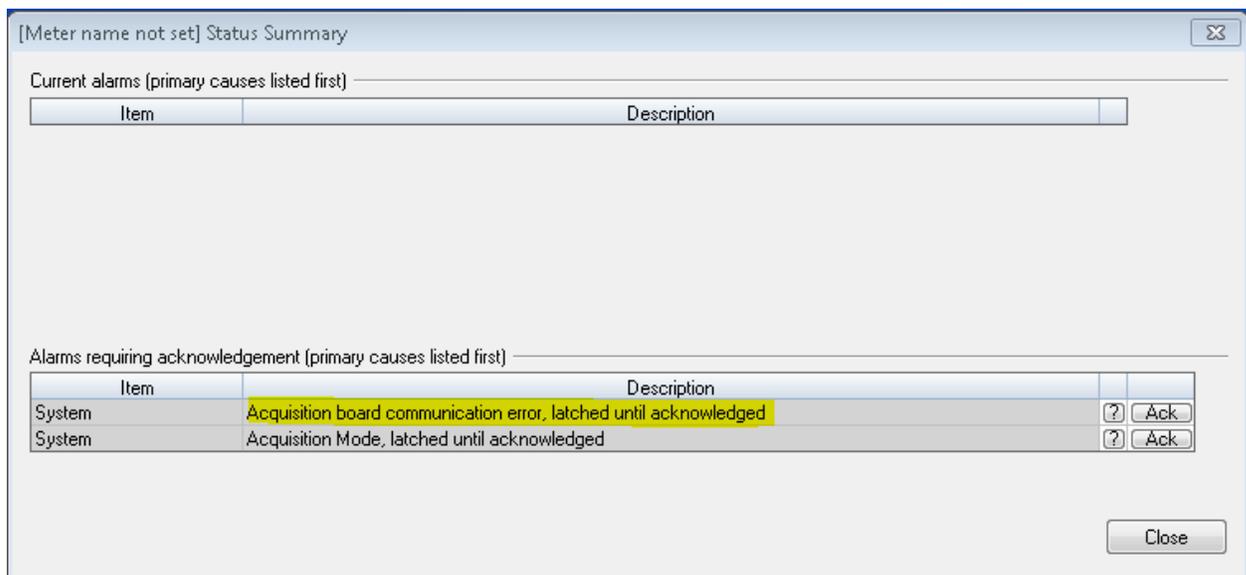
Figure 2: MeterLink Meter Status Summary

Figure 1 identifies the log Messages most commonly associated with the solder issue. For intermittent connections, “Unrecognized remote FPGA error” may only be observed in the system log. Depending on the severity of the issue, “Remote FPGA not responding and unable to initialize its” messages may be observed in the system log and “IsCommErrAcqBd” alarms may be observed in the Alarm log at similar time periods. These messages indicate the CPU is not communicating to the Acquisition board properly. With minor solder issues, the “Unrecognized remote FPGA error” may only be observed and the meter may show no observable signs or symptoms. In severe cases, the system and alarm logs will have repeated occurrences of these messages and the meter will show symptoms where all chord measurement drops out intermittently or permanently. In these situations, the meter status as reported by MeterLink will indicate a latched Acquisition board communication error. This is an indication that the CPU lost communication with the Acquisition board for a period of time but was able to reestablish communication. Repeated occurrences of these messages after acknowledgment are symptoms of the solder issue. If the communication to the acquisition board was not re-established, the message would be listed in the Current alarm section.

If relevant messages are observed in the log record and/or the meter is showing symptoms of communication problems, it is recommended to immediately contact Daniel Service for assistance. Daniel personnel can evaluate log records and/or meter symptoms and make recommendations on proper resolution. Upon verification of the solder issue, repair or replacement options will be provided.

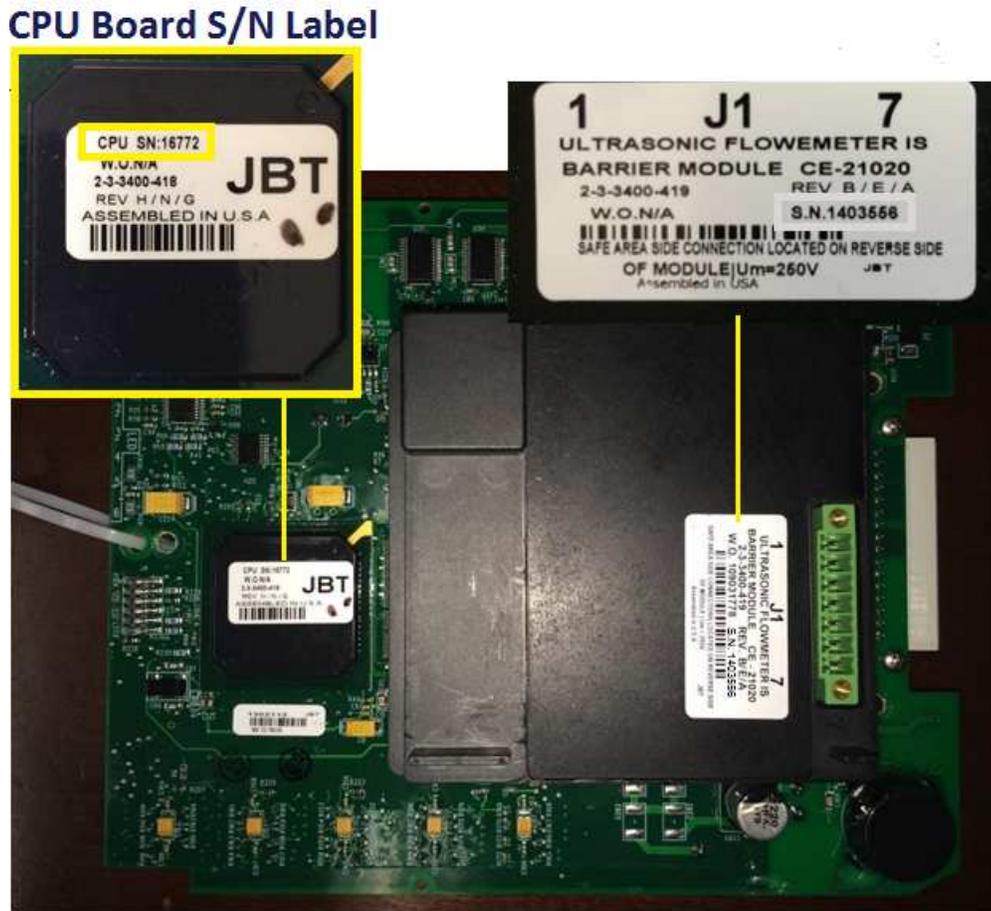
Figure 3: Location of CPU and IS Barrier Module Serial Numbers

- P/N 2-3-3400-418/425 - CPU S/N Range 15500 to 19000

The serial number of each board can be found by serial number tags located on the assembly. Figure 3 shows the location of the serial tag and designates the location of the serial number.

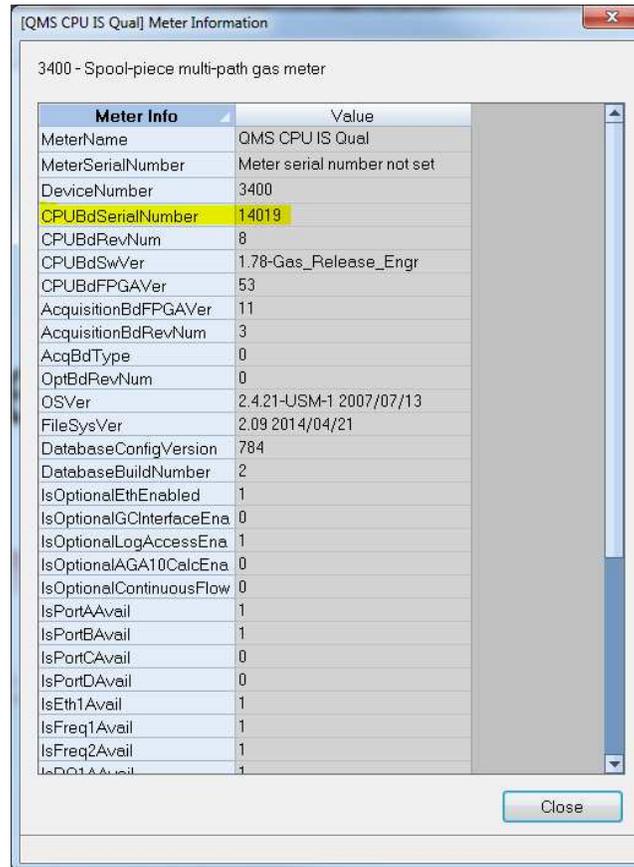
Figure 4: CPU Board Serial Number as displayed on the MeterLink Meter Information Screen

The serial number of the CPU Board can be viewed in MeterLink by Selecting Meter -> Meter Information from menu options. The CPU serial number is listed as CPUBdSerialNumber in Meter Information window as shown in Figure 4.
