# TESTING HIGH-NICKEL ALLOY CASTINGS IN REFINERIES

Refiners today are increasingly dealing with more corrosive feedstocks that present new demands on valves in the process. However, maintenance personnel can detect problems before they become major issues by using different testing methods.

BY JAMES L.  
GOSSETT

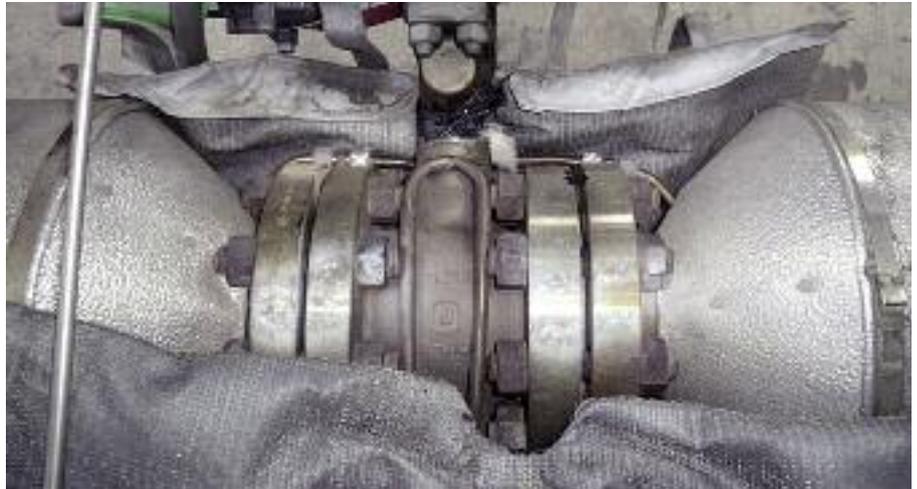
In 2009, a Minnesota-located refinery was experiencing through-wall leakage with several Class 300 rotary valves tasked with controlling crude unit vacuum prefractionator charge heaters. Maintenance personnel removed insulation from the valves and noted coke residue on the surface of the valve bodies, which identified for them where the leaks were occurring (Figure 1).

Figure 1. Removing insulation from around the ball valve in question revealed leakage locations.

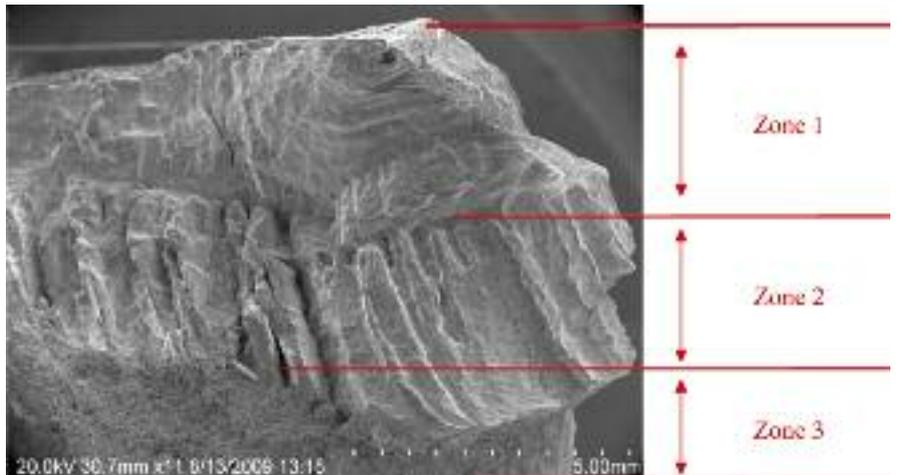
Figure 2. Opened defect showing three zones of fracture. Original magnification 11x.

Fracture surfaces from the neck area of the same valve body were examined using SEM (Figure 2). The first zone examined was an outer layer that was approximately 0.03 to 0.06 inch (0.8 to 1.5 millimeters) thick. This chill layer solidifies rapidly when the molten metal first contacts the mold surface.

The second layer or zone 2 of the fracture has a dendritic pattern. This pattern represents columnar grains that grew perpendicular from the chill layer during the balance of the solidification process. The neck was cast solid so all the grain growth was from the outer diameter to the center. The center of the

Zone 3 was ductile, dimple shear. This is the fracture mode seen on any mechanical break produced in the lab.

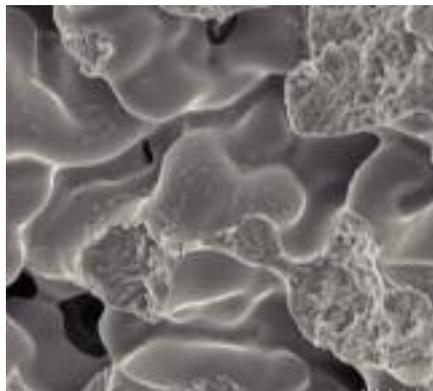
Figure 3. Rounded dendrite fingers indicating a shrinkage defect. Original magnification 600x.

Within the dendritic zone of some of the fractures were rounded dendrite arms (Figure 3). The rounding indicates a shrinkage defect caused by an isolated area of liquid that was frozen off from the riser system because it was not properly fed. When the liquid was consumed during solidification, the dendrite arms could not continue to grow, leaving the blunted tips. Dark areas, which were identified as oxide films formed from exposure to air during casting solidification or heat treatment, were also found on the lab fractures. This proves the fractures were present before the casting went into service.

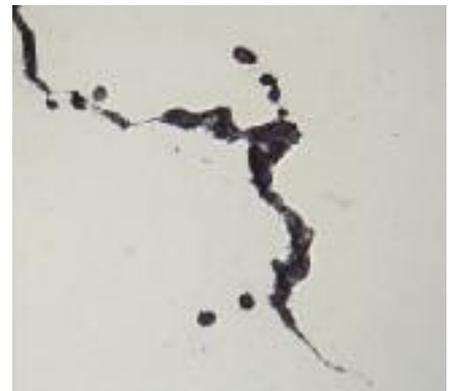
Figure 4. Photomicrograph showing the leak path and the continuation of the grain boundary. Original magnification 500x.

Inclusions and porosity also were visible. The inclusions were mold sand, slag and oxides. The grains were very large compared to wrought product forms—about 1/4 to over 1/2 inch (6 to 13 millimeters). The grain boundaries were the intersection of the dendrites formed during solidification. One leak

path was cross-sectioned (the photomicrograph in Figure 4 shows the continuation along a grain boundary).

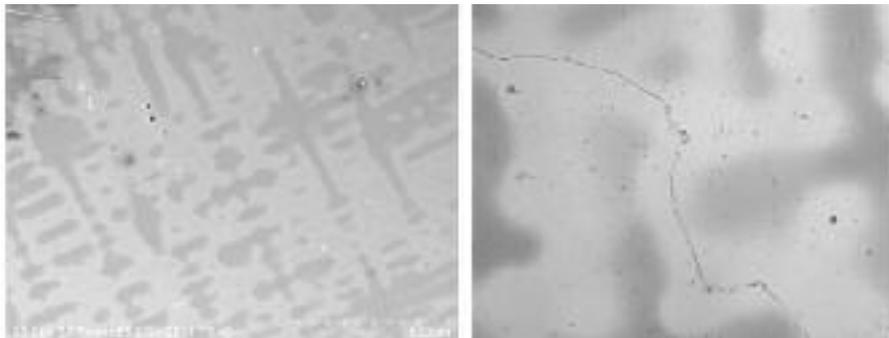
**Figure 5. The as-cast microstructure contains elemental segregation and undesirable phases in the interdendritic spaces. Original magnification 85X (left), 500X (right).**

In the as-cast condition, segregation and second phases could be seen in the secondary electron SEM image (Figure 5). The heavier average atomic mass produces a lighter image while the lighter average atomic mass produces a darker image. The darker dendritic regions are enriched in the lighter elements, chromium and nickel, while the lighter interdendritic regions contain higher concentrations of the heavier element molybdenum. The second phases are undesirable because of reduced toughness and susceptibility to preferential corrosion attack.

Proper solution heat treatment is required to reduce the segregation and second phases to a minimal level.

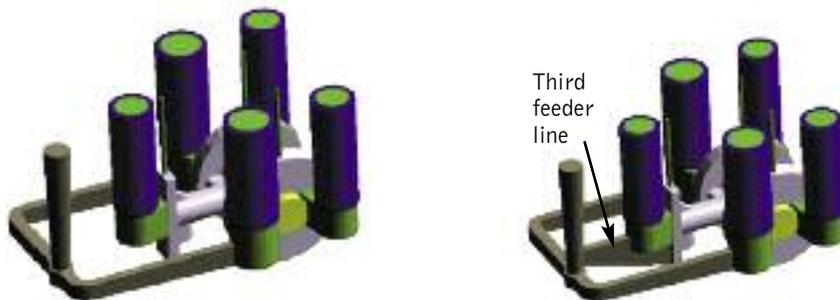
**Figure 6. Casting rigging with two-feeder method at left and three-feeder method at right**

Analysis of the mold-filling technique used for the original castings revealed a deficiency in the feeding or rigging method. The mold was filled through two feed paths into the flanges (Figures 6 and 7). The lower half of the flanges filled first, then the center section of the body, and finally the neck and foot area.

A high level of turbulence was created as the metal flowed into the neck and foot. The turbulence produced reoxidation of the metal, which introduced oxide defects. The metal was also relatively cold when it reached this area, which created excessive tensile stress in the neck from the highly constrained foot as the solidification progressed back toward the main body.

Casting simulation using a three-feeder system (Figures 6 and 7) demonstrated a less turbulent fill that promoted a desirable directional solidification from the body out towards the foot. This change minimized the highly constrained situation where the foot solidified first.

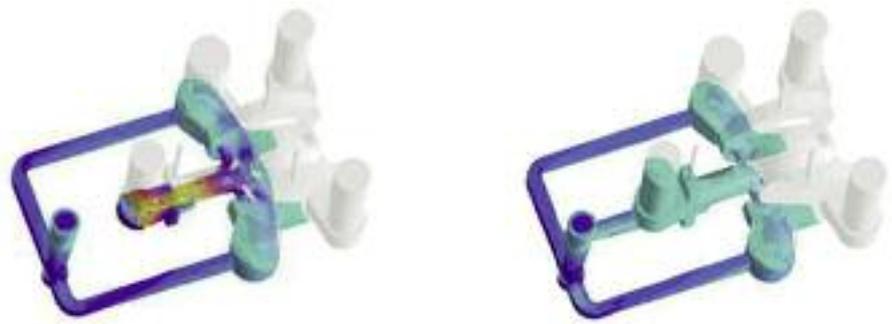
**Figure 7. In the two-feeder casting method (left), a high level of turbulence was created as the metal flowed into the neck and foot. The three-feeder casting system resulted in tranquil and low-velocity fill.**

The through-wall leak path in the neck area was due to shrinkage and thermal stresses caused by the two feed path rigging system. The surface indications were caused by interdendritic cracking formed during the solidification process or during the heating portion of solution heat treatment.

Casting simulation provided a solution that reduced filling turbulence and promoted directional solidification from the body out towards the foot. This minimized the highly constrained situation
