Tissue Machine Bearing Failure and PeakVue Problem Resolution

Introduction

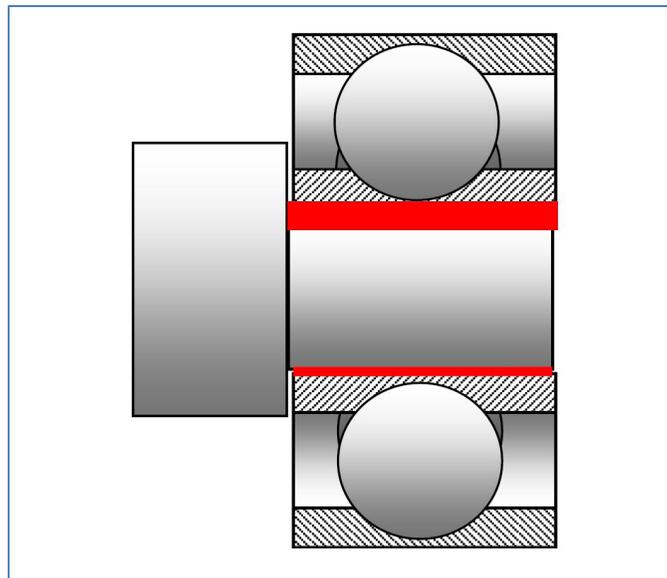
On November 23, 2005, the 16 Tissue Machine After-dryer T3 tending-side bearing had a significant failure. The bearing failed after an audible noise and high temperature was noted on the bearing housing. Upon inspection of the front side bearing, a 1/8" drop in the bearing position was observed; the inner race and the retaining ring were not found in their correct positions. Two of the three lock down bolts were missing with one bolt sheared off, resulting in bearing and journal damage. The other missing bolt disintegrated, its debris is believed to have plugged the oil return line. The last bolt was in position, partially holding the retaining ring. Oil flowing into the bearing housing indicated that the bearing had lubrication before failure. Six of the eight front-side After-dryer bearings were inspected during this repair, and nothing was found out-of-standard.

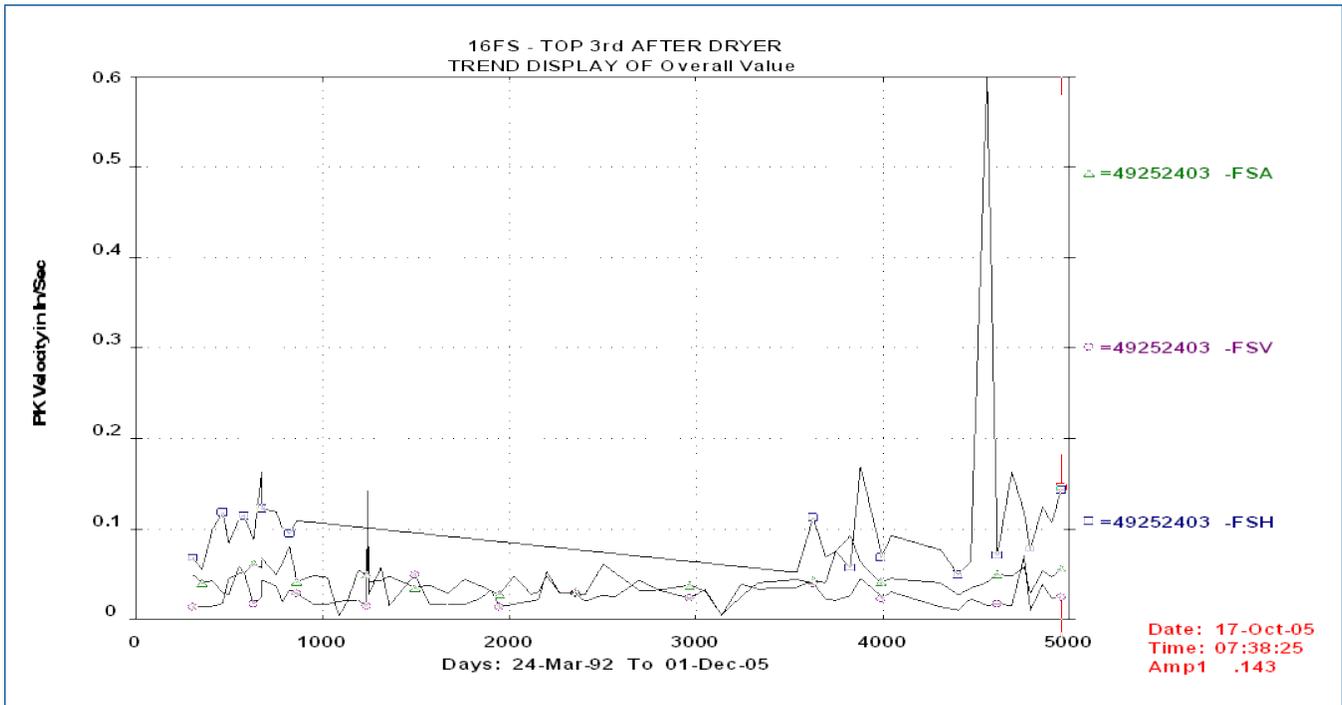
Aside from a minor increase in the axial amplitude, the vibration data from October 17th did not show any signs of defect prior to the bearing failure. As a result of the audible noise emanating from the bearing, an inspection was recommended. Shortly after these readings, the T3 bearing failed before a shutdown inspection could be performed. After this failure, PeakVue monitoring was added to the route for all tissue machine rolls.

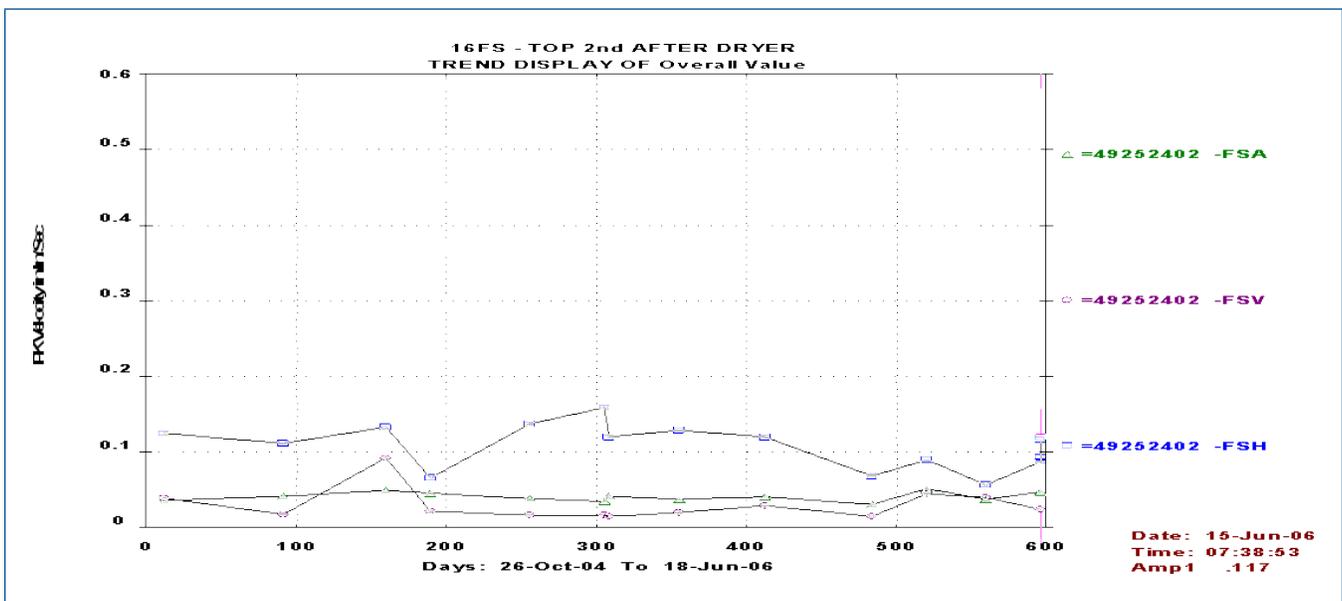
On June 15, 2006, vibration analysis was requested on the 16TM T2 After-dryer tending-side bearing. This was on the same After-dryer section of the tissue machine as the previous failure. An intermittent audible noise was emanating from the F/S T2 bearing. Vibration data was collected on the bearing along with PeakVue readings. Horizontal, vertical and axial vibration amplitudes were low, below 0.12 ips on the bearing housing readings.

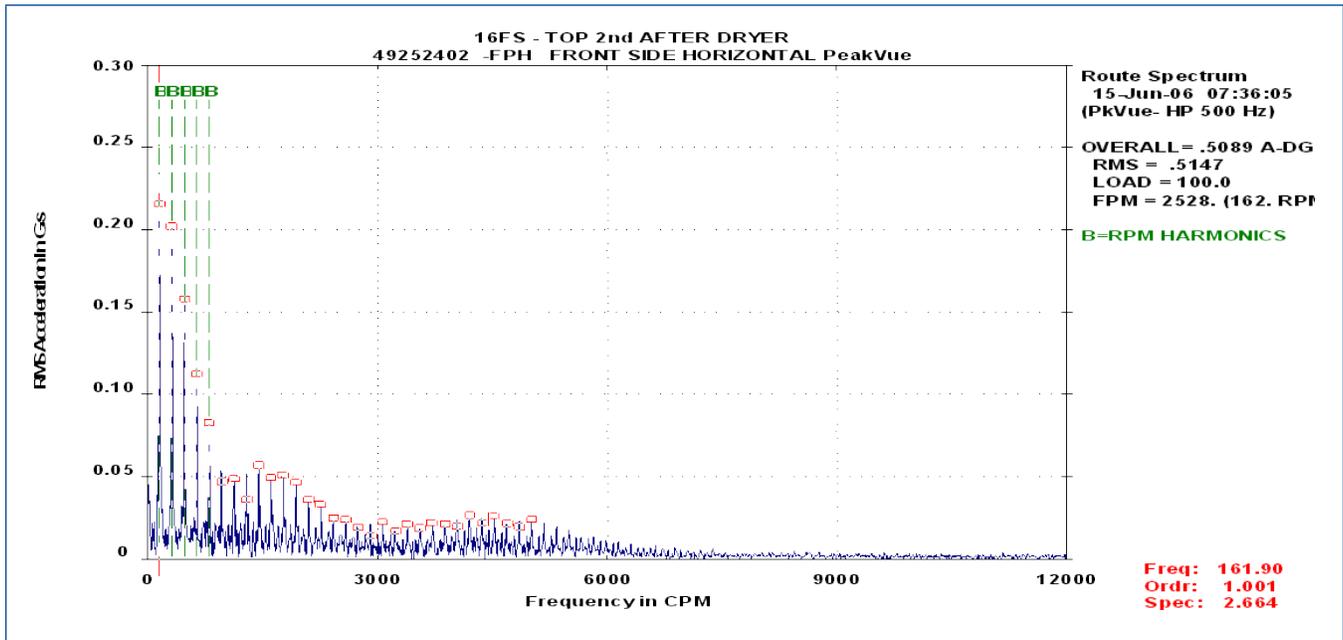
PeakVue data contained multiples of TS, and the overall PeakVue value increased when the audible noise was louder.

Multiples of turning speed is typically indicative of looseness in vibration readings. The multiples of turning speed in the PeakVue data reached 3.4 G's p-p when the audible noise was at its highest value. This may have been from load variations on the bearing. Although PeakVue amplitudes were low, severe damage was found during the maintenance inspection. When multiples of turning speed is indicated in PeakVue measurements, maintenance inspection of the bearing should be considered to avoid failure of the machine component.

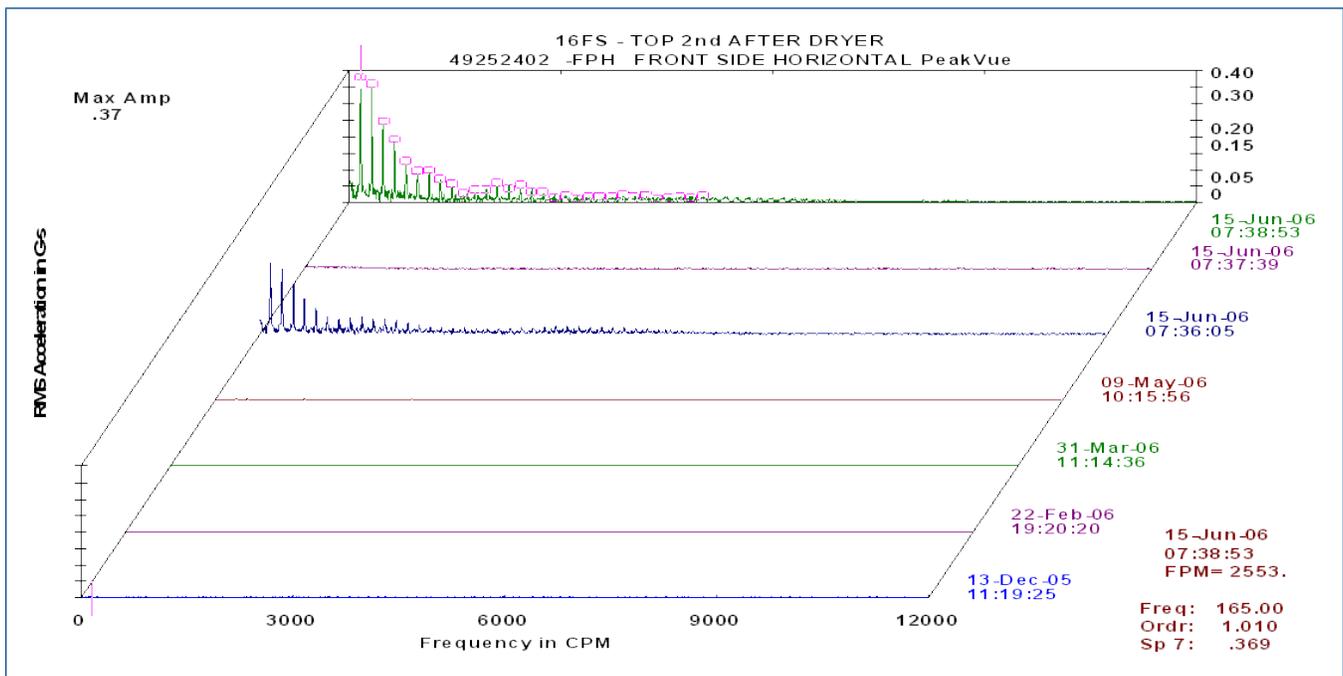
Three PeakVue readings were collected at that time, which are displayed in the waterfall plot below. The middle June 15th reading was taken when the audible noise decreased. An analysis of the collected data was performed and a report generated. Recommendations were made to increase monitoring of the bearing PeakVue and temperature values until maintenance could be performed. An inspection of the bearing for looseness or wear was also recommended at the next opportunity.

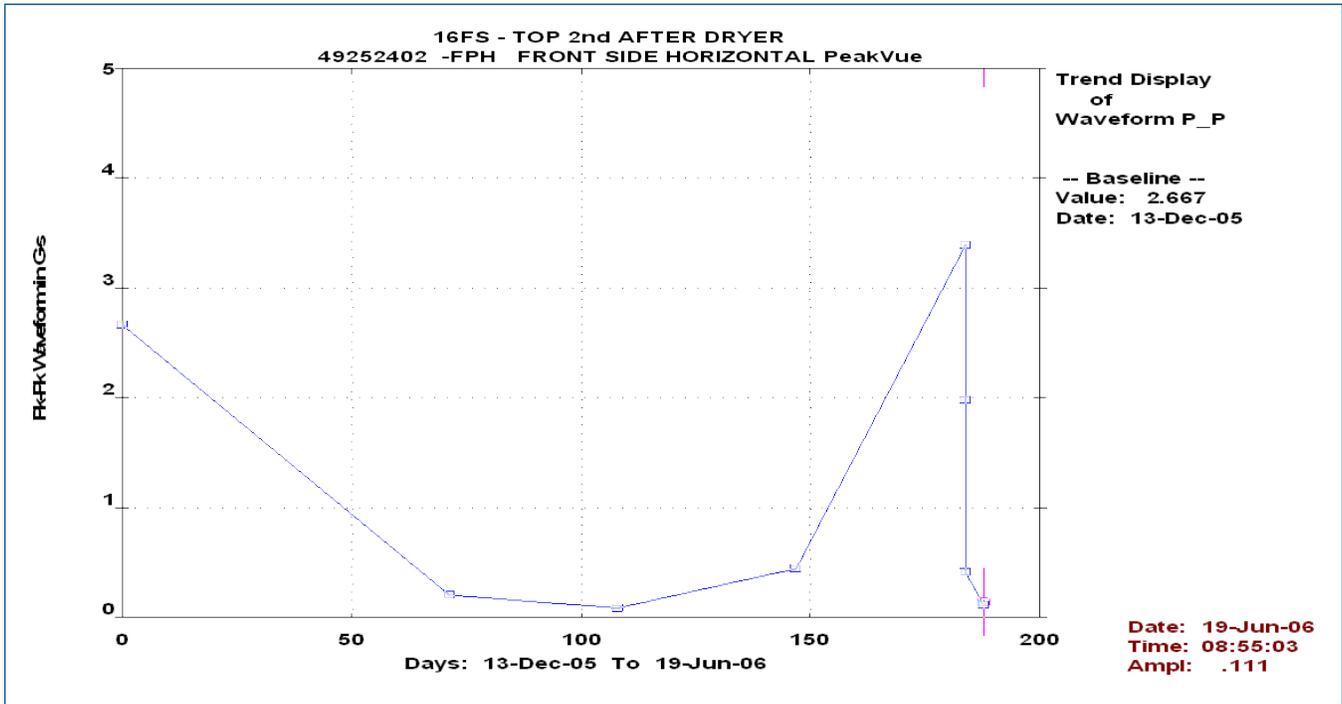
Because of production requirements, the bearing was flooded with oil to maintain TM operation. Readings on June 19, 2006 found that the audible noise and PeakVue values decreased. The problem still exists but was masked by excessive bearing oil. Recommendations to inspect the bearing and perform monitoring until maintenance was possible were reiterated.

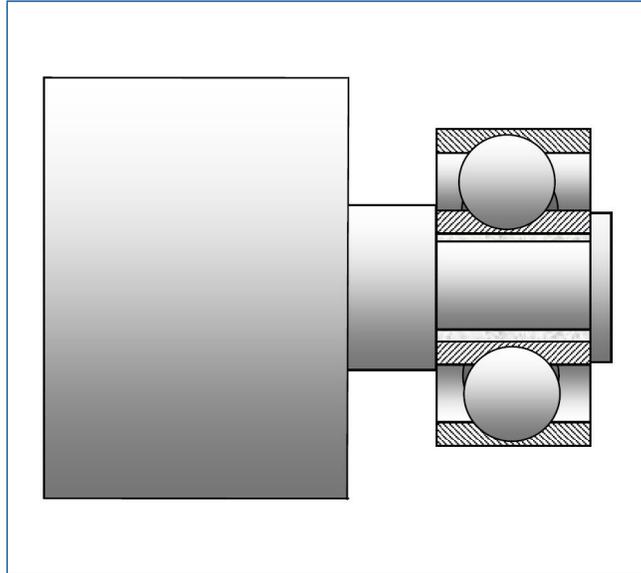
A TM shutdown was scheduled for June 20th and an inspection of the After-dryer T2 Roll bearing was performed at that time. The inner race was found to be loose on the shaft. Measurements on the journal found it to be severely worn where the bearing inner race was spinning on the shaft. A compression fit is used on this configuration to hold the inner race in-place on the roll journal. The journal was machined and a sleeve was installed along with a new bearing.
