Impact Detection

Improving Dialogue between Operations and Maintenance

Power Plant in the USA

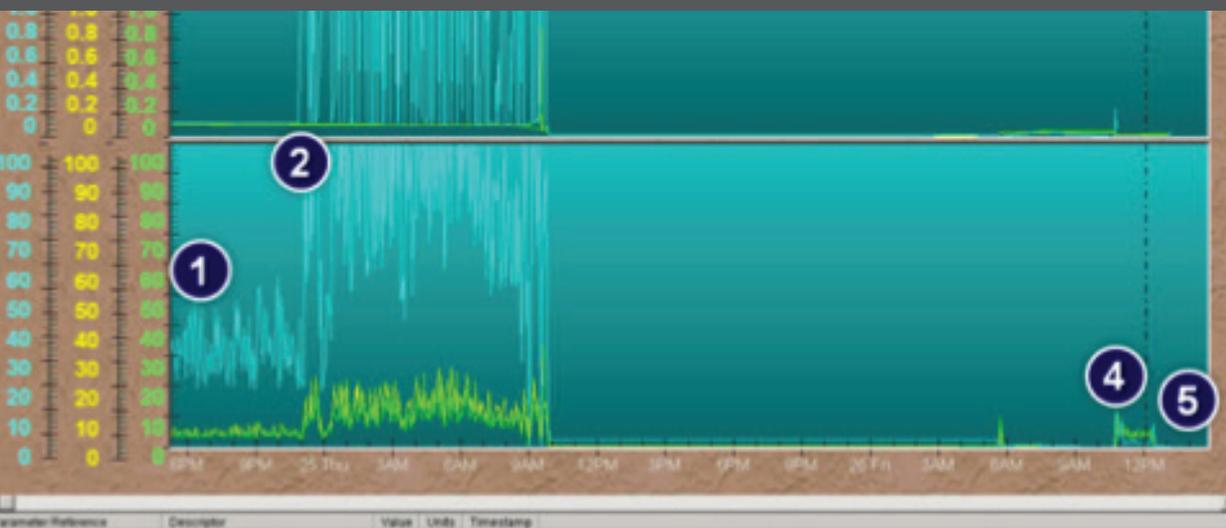
The power plant installed an Emerson transmitter on the atomizer and included PeakVue technology. At the point of start-up indicated in the graph (area 1), the overall vibration readings (indicated by green line) were all below acceptable levels. In contrast, the PeakVue readings on one bearing (blue line) were already ranging from 30 to 40 g's— indicating that a critical bearing fault was likely already in play.

Six hours later, around midnight, the vibration at this bearing location (area 2 of graph) shifted dramatically. The PeakVue levels rose sharply to above 100 g's, while the overall vibration level jumped suddenly from baseline to nearly ten times the fail-alert level. Both of these changes indicated that the bearing was in the process of failing. The control room communicated with maintenance planning to schedule maintenance for the following morning and continued to monitor the machine closely.

By about 9 am, the overall vibration level (area 3 of graph) on an adjacent bearing suddenly increased sharply from baseline level to about ten times the fail-alert level. At this point, operations made an immediate call to shut down the process.

The defective bearing was replaced, and the machine was scheduled for start-up the following morning (area 4). The operator, familiar with PeakVue's Zero Principle, noted that the machine was running at nearly 10 g's at start-up. He contacted maintenance and asked them to check out the machine. As result of the PeakVue warning and the operator's prompting, the maintenance team discovered the root cause of the repeated failures on this machine: the grease fitting was clogged. As a result, when they lubricated the bearing, only a fraction of the grease actually made it to the bearing.

The maintenance team cleaned the grease fitting, reapplied lubrication, and as expected, the PeakVue readings dropped below 1 g (area 5). The same asset that had previously failed every three months for more than a year has now been running for more than two years without incident.
