Daniel Gas and Liquid Ultrasonic Meters CPU Board Log Memory Technical Bulletin

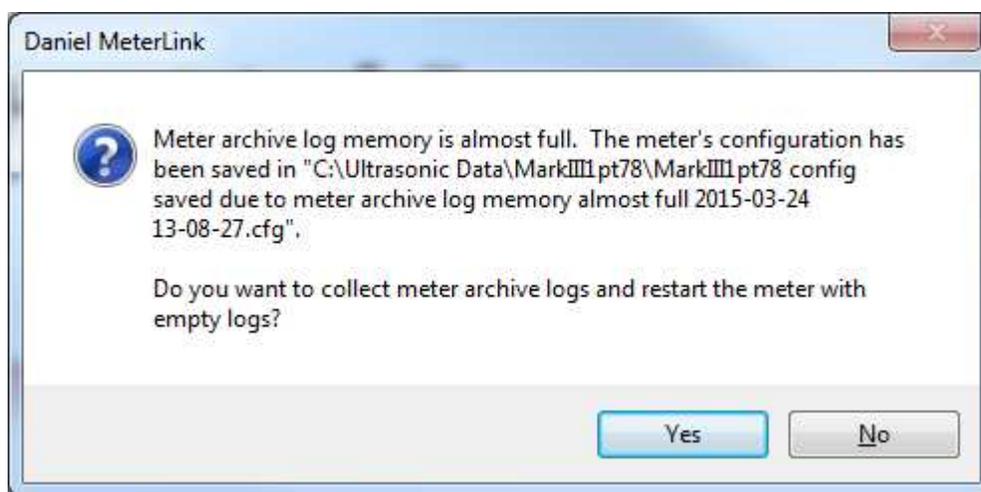
- Connect to meter using MeterLink v1.21 (or later).
- Use Program Download Utility in Meterlink to upgrade firmware to v1.78 (or later)
- After firmware upgrade completes, meter will reboot.
- Connect with Meterlink.
- If the Mark III (v1.78 or later) archive log memory is too full, MeterLink v1.21 (or later) will display the following message upon connecting to the meter:

-
- If **No** is selected, no action is taken. The same message will appear each time a meter connection is made until the log memory is cleared.
 - If **Yes** is selected, the Meter Archive Logs dialog is opened so that the user can collect meter archive logs:
