PeakVue Analysis for Antifriction Bearing Fault Detection

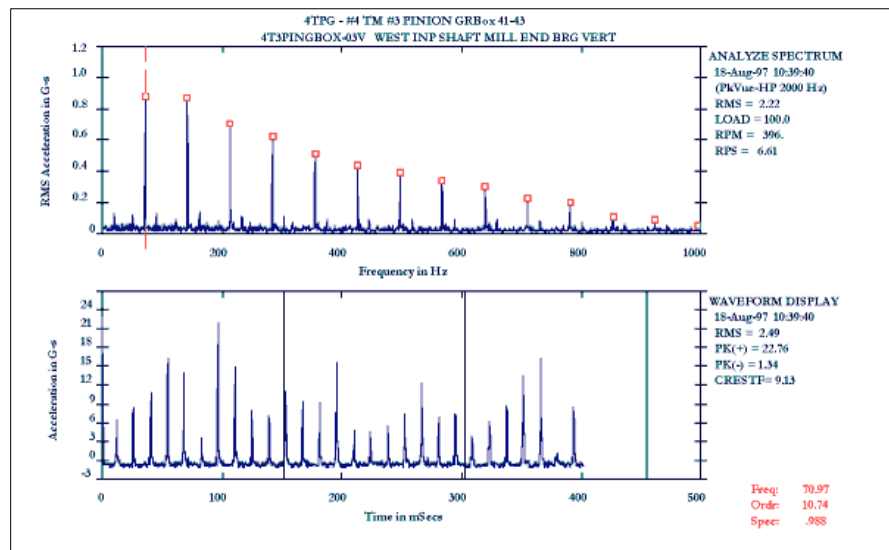
The PeakVue spectra and time waveform data are presented in Fig. 1. A high pass filter of 1000 Hz was used. Significant activity at the outer race defect frequency with many harmonics is present. The impact levels are as high as 37 g's.

Figure 1: PeakVue Spectra and time waveform from input shaft of pinion stand gearbox

Although many harmonics are present in the spectral data, it is obvious from the PeakVue time waveform that the time between impacts corresponds to the outer race fault frequency (the harmonics are of no physical significance). This is also demonstrated in the autocorrelation coefficient function presented in Fig. 2.

The impacting levels trended from 18 g's in July to a high of 37 g's in September. The levels had decreased to 14 g's in October prior to a bearing replacement.

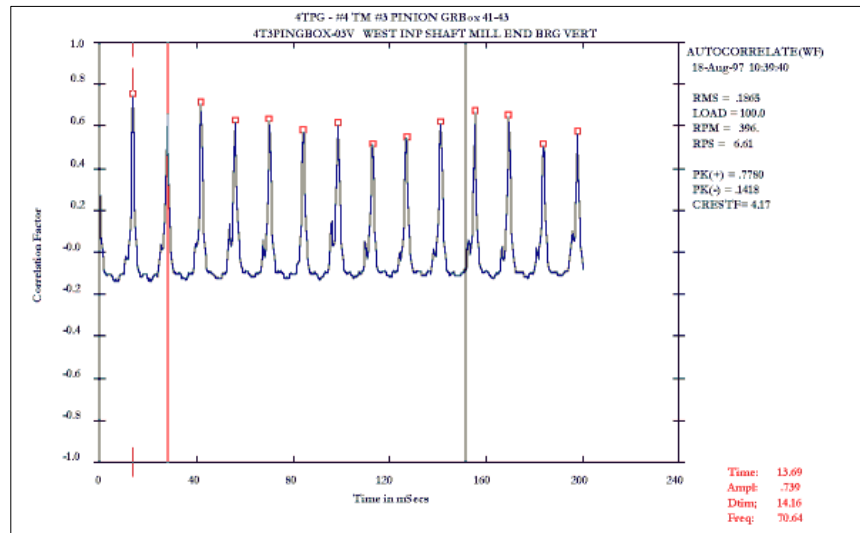
Figure 2: Autocorrelation coefficient from PeakVue time waveform in Fig 1

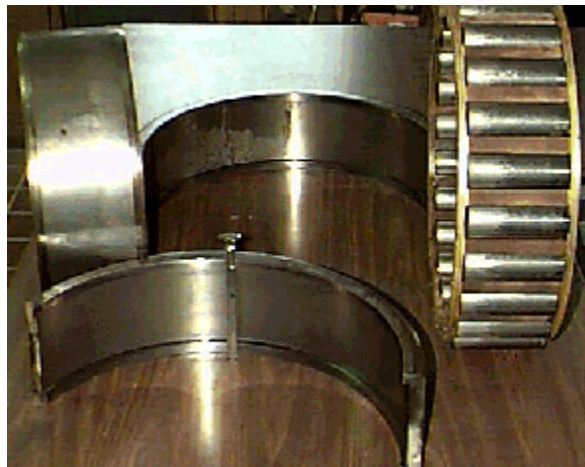
Figure 3: Photograph of defective bearing from the inlet of pinion stand gearbox

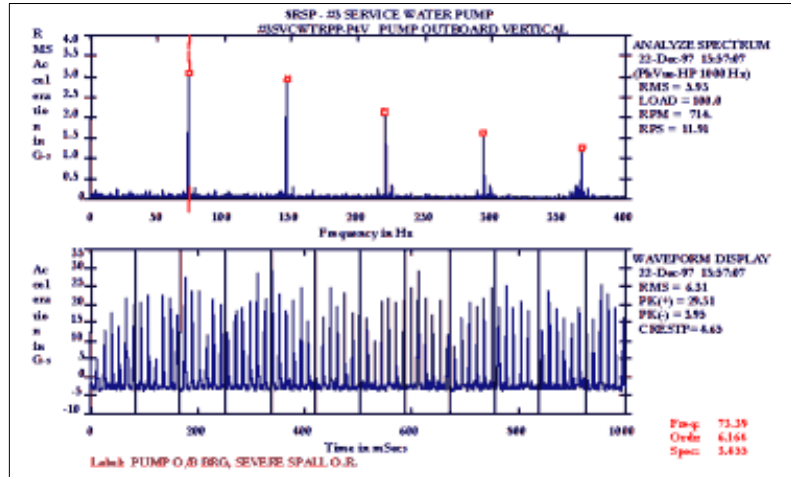
and inner race defects with a signal level of 10 g's. A second PeakVue reading was taken on December 22, 1997 and is presented in Fig. 4. The impacting levels had increased to 33 g's. The pump was then placed on the "fault" level and the bearing was replaced. The autocorrelation coefficient computed from the PeakVue time waveform is presented in Fig 5. The autocorrelation coefficient data shows the only activity of significance is the impacting from the outer race defect.

Figure 4: PeakVue spectra and time waveform from outboard on service water pump

In this case, normal vibration data did identify the fault; however, the low levels observed did not place the fault at a level of significant concern. The impacting levels identified in PeakVue, excess of 30 g's, raised the concern level and initiated planning for replacement.

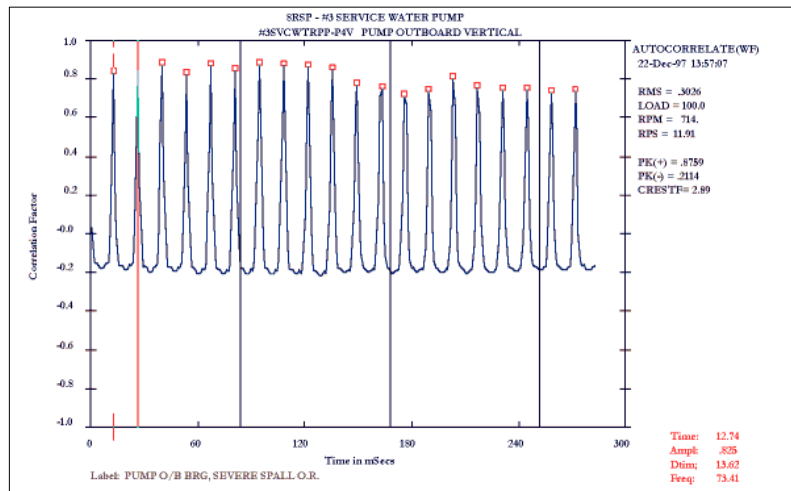
Figure 5: Autocorrelation coefficient from PeakVue waveform in Figure 4.

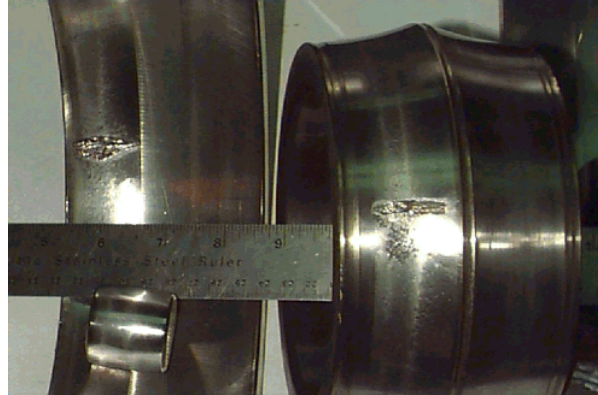
Figure 6: Photograph of defective service water pump bearing, showing inner and outer race spalling.

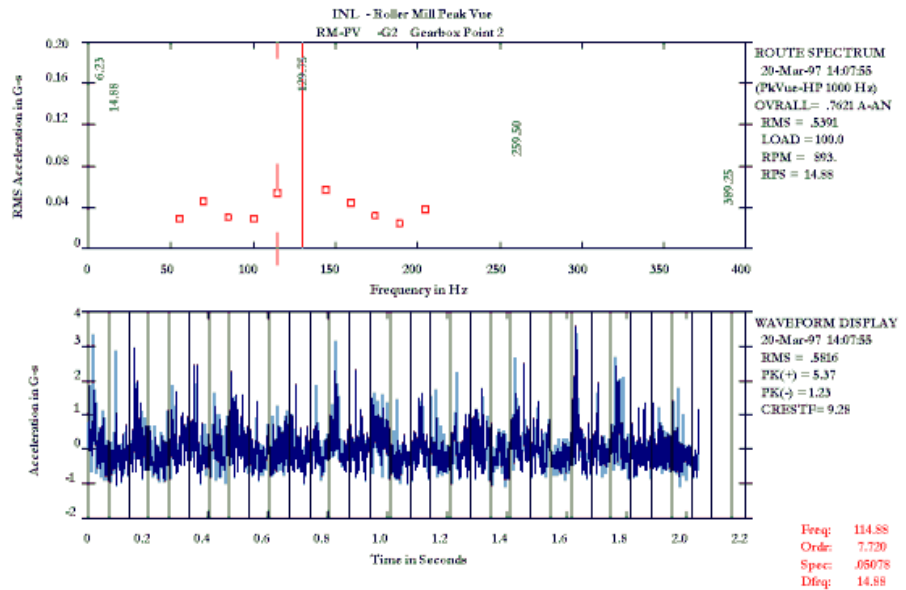
The PeakVue data acquired March 20, 1997 are presented in Fig. 7. The cage activity at 6.23 Hz (0.42 orders) is identified. The inner race defect (129.75 Hz) at 8.72 orders is being sidebanded by running speed. The inner race defect was not detected in the normal

spectral analysis.

Figure 7. PeakVue spectra and time waveform from inlet of crusher gear box.

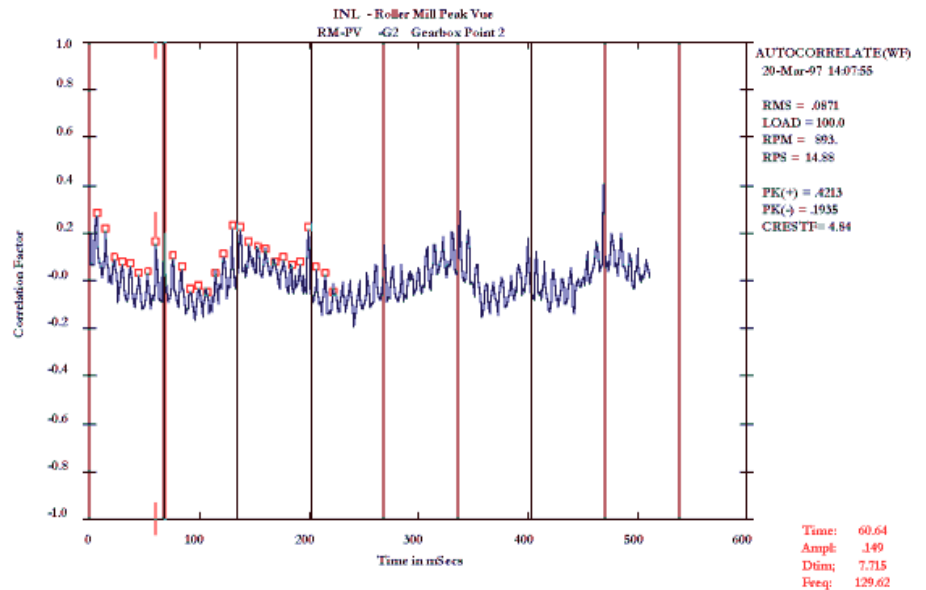
Figure 8. Autocorrelation coefficient from PeakVue time waveform of Figure 7.

The autocorrelation coefficient function computed from the PeakVue time waveform in Fig. 7 is presented in Fig. 8. The inner race defect is clearly evident with amplitude modulation at running speed. The peak g levels for an inner race are generally not as large as for those accompanying an outer race defect. This is expected since the stress waves accompanying an inner race defect will experience attenuation in reaching the outer

peripherals (where the sensor is attached) of the machine.

The bearing was replaced in June, 1997. The inner race had deep spalling over an approximate 1 1.5 area.

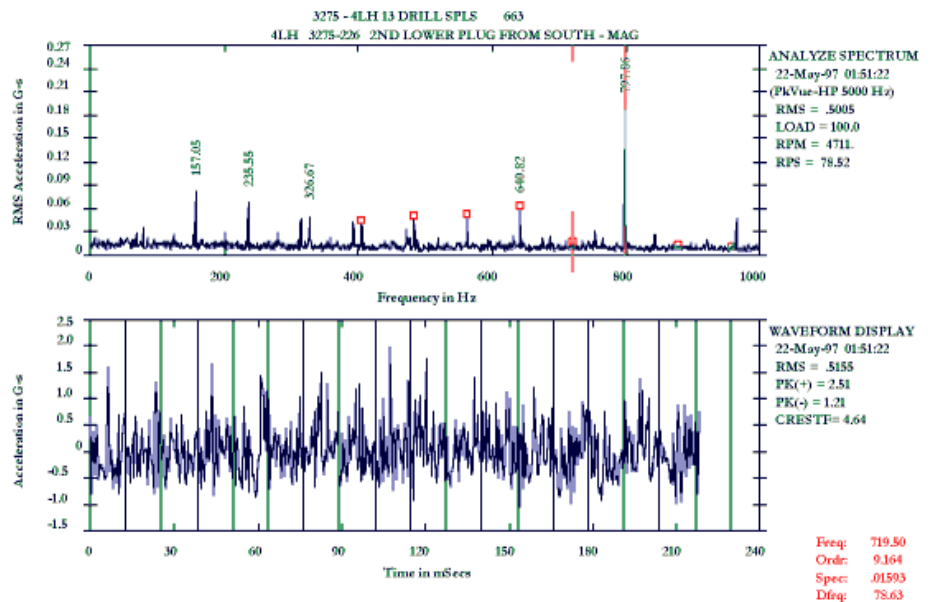
Figure 9. PeakVue spectra and time waveform from a spindle on a 13 multi-drill head spindle.

The PeakVue spectra and time waveform for a spindle with a confirmed inner race defect are presented in Fig. 9. The inner race defect at 797.86 (10.2 orders) Hz is identified with side banding (twice running speed is dominant). The autocorrelation coefficient function computed from the PeakVue time waveform is presented in Fig. 10. The dominant activity here is at the inner race defect frequency. The bearing was replaced. The bearing had deep spalling on the inner race

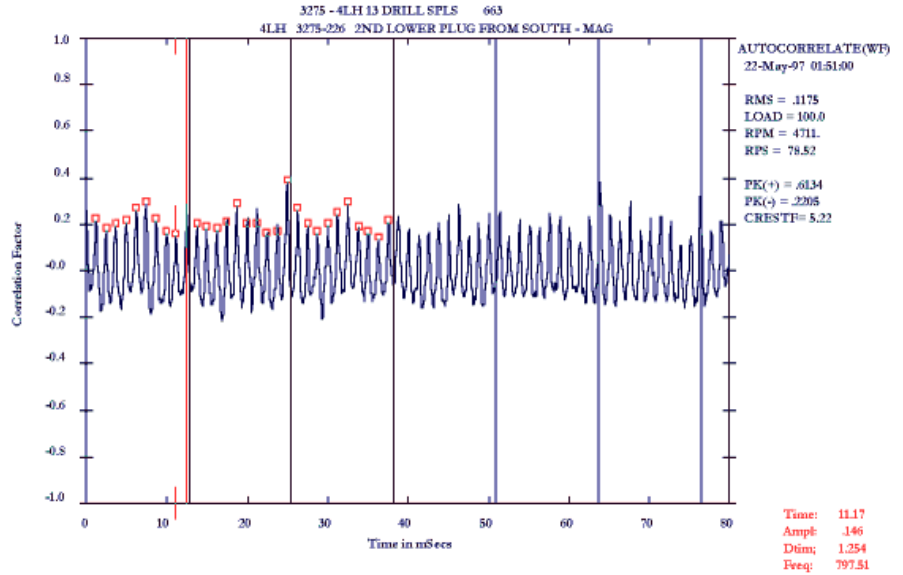
Figure 10. Autocorrelation coefficient from PeakVue time waveform acquired on the spindle of Figure 9.

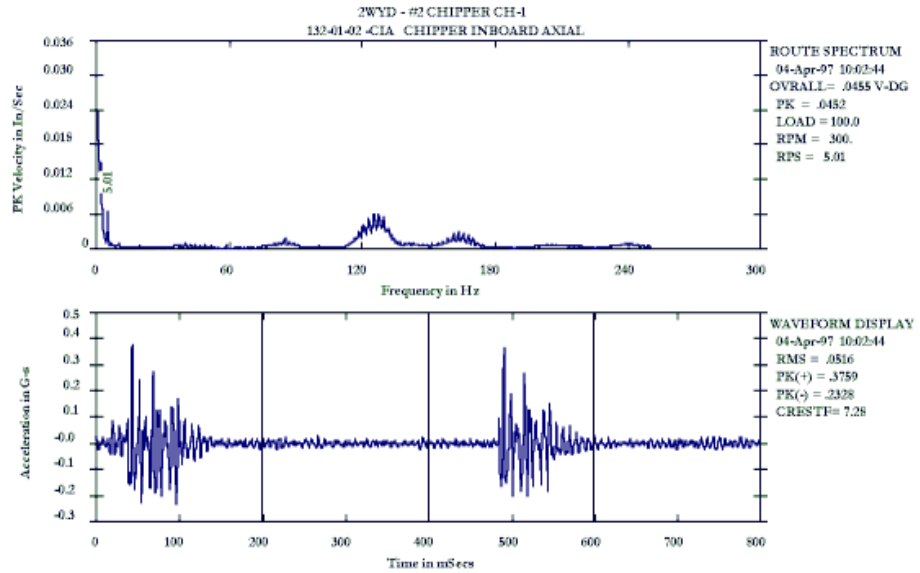
Following a shutdown where work was done on this chipper machine, the acceleration time waveform for a 500 Hz bandwidth spectra indicated some impacting may be occurring, see Fig. 11. The p-p g levels were less than 1 g which are not judged to be significant. The velocity spectra had a low 1x component but there were no obvious bearing faults.

Figure 11. Velocity spectra and acceleration time wave form from inboard axial on a chipper.

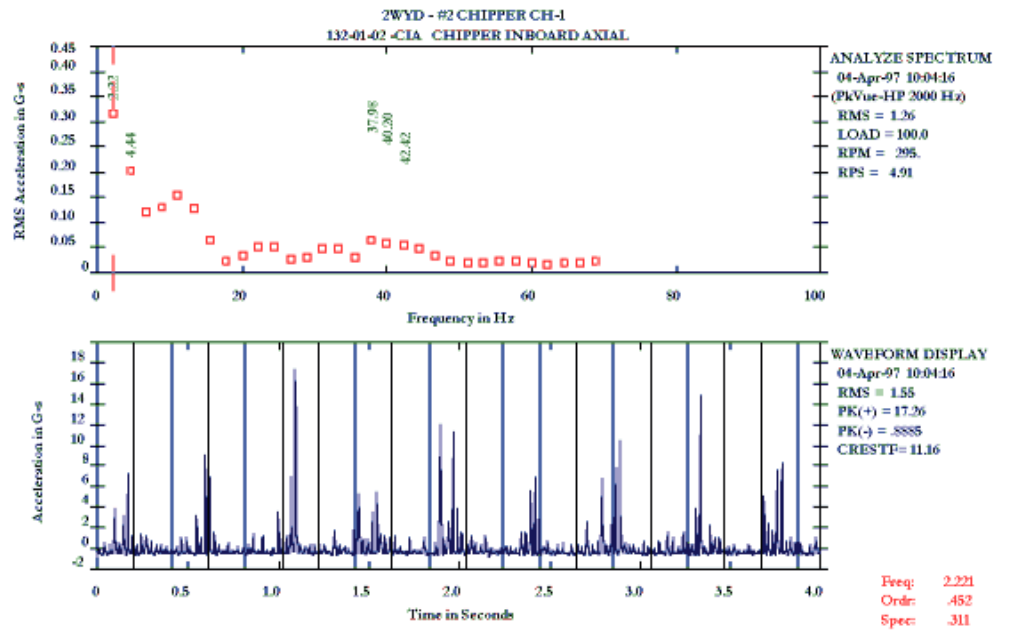
Figure 12. PeakVue Spectra and time waveform from inboard axial on chipper.

A PeakVue data set was acquired at about the same time using a high pass filter of 2000 Hz. The resulting PeakVue spectra and time waveform are presented in Fig 12. The impacting level is near 20 g's and the cage and twice ball spin frequencies are dominant. This pattern is indicative of two impacts per revolution of the ball that is passing through the load zone at the cage repetition rate. From the PeakVue spectral data, it is not obvious whether the 38, 40.2, or 42.4 Hz peaks are representative of twice ball spin. The autocorrelation coefficient function data, presented in Fig. 13 clearly identifies the dominant activity is at 40.2 Hz which is twice the ball spin frequency. The autocorrelation coefficient data also clearly shows the defective ball going in and out of the load zone at the cage turning speed.

The root cause of this problem was found to be improper grounding of an electrical welder used during the recent outage.

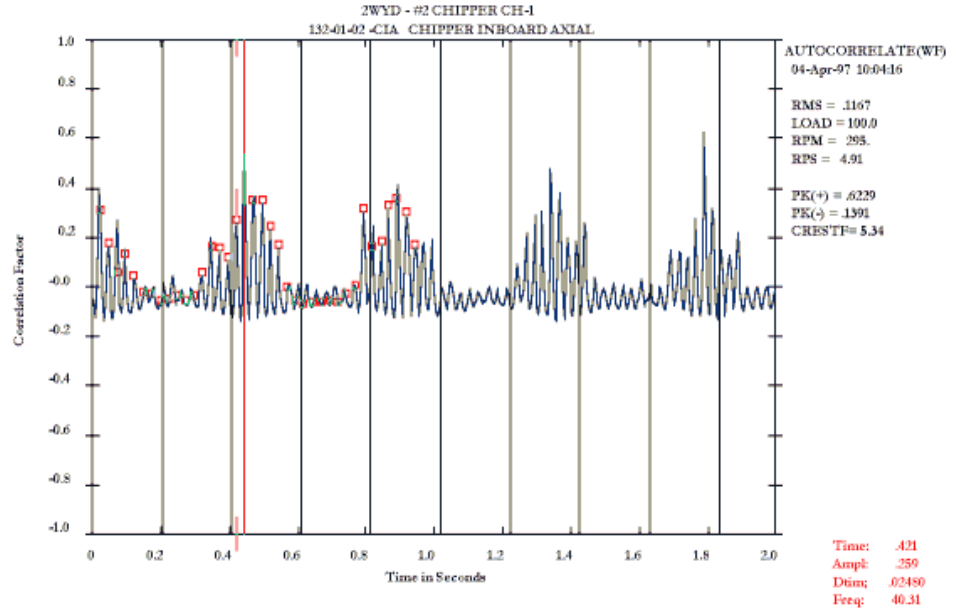
Figure 13. Autocorrelation coefficient from PeakVue time waveform of Figure 12.

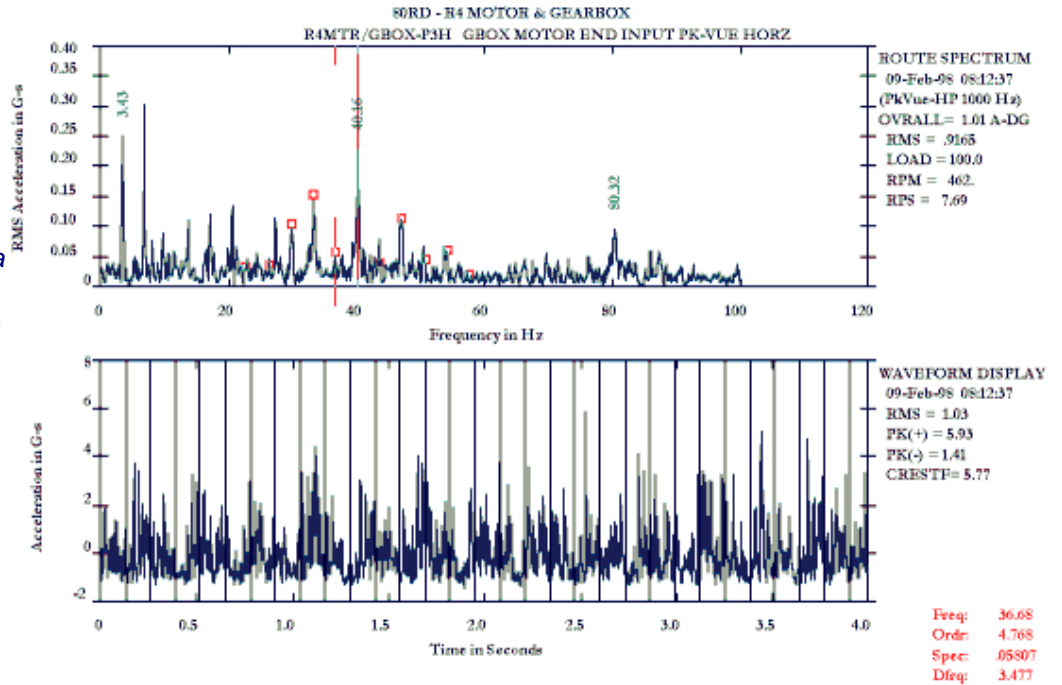
When data was acquired on the inlet pinion shaft bearing on January 2, 1997, impacts in the 6 g range were detected with the PeakVue spectra showing ball spin fault modulated by cage. On February 9, 1997, the impacting level had increased to 9 g's. The PeakVue data are presented in Fig 14. The ball spin fault frequency is at 40.4 Hz and cage at 3.43 Hz. The autocorrelation coefficient is presented in Fig. 15 which

Figure 14. PeakVue Spectra and time waveform from inboard pinion rougher gear box.

The bearing was replaced and PeakVue data acquired on February 12, 1997. The impacting level had decreased to less than 1 g. The normal vibration never showed any indication of a bearing problem.

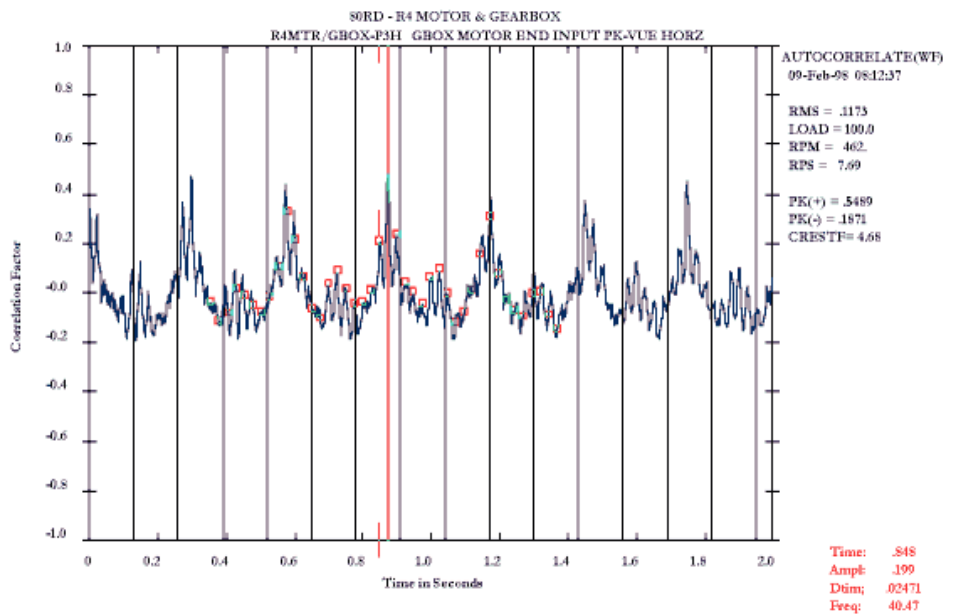
emphasizes the cage and ball activity. A photo of the defective bearing is presented in Fig. 16.

Figure 15. Autocorrelation coefficient from PeakVue time waveform of Figure 14.

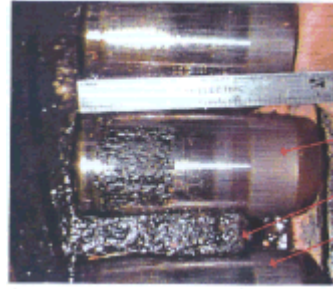
Figure 16. Photograph of defective bearing highlighting the rollers.

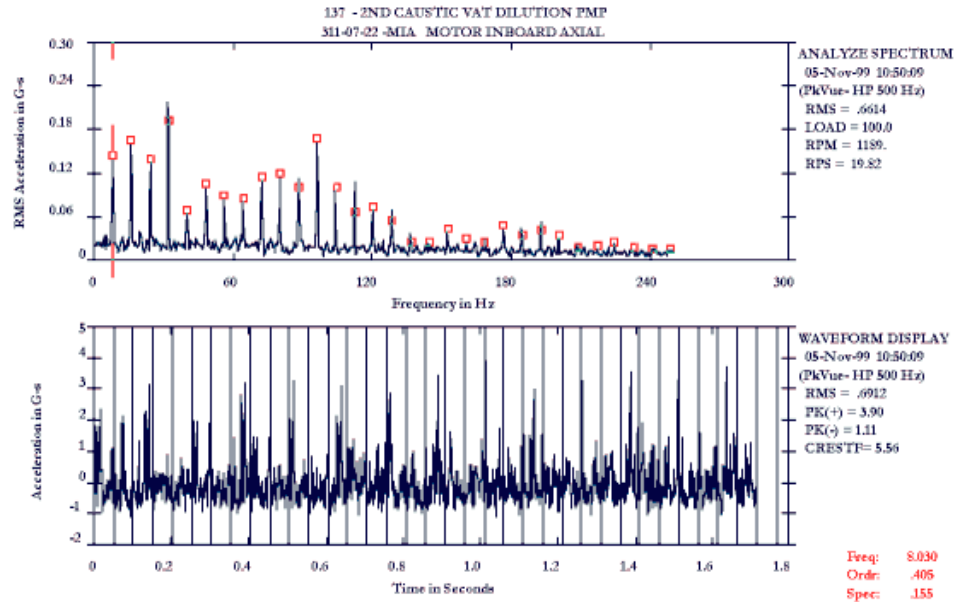
The PeakVue data from the inboard bearing on a motor (150 hp) directly driving a centrifugal pump are presented in Fig. 17.

Figure 17. PeakVue spectra and time waveform from Motor (Inboard Axial) driving direct coupled centrifugal pump.

The impacting levels are 5 g's which are not excessive for this speed machine but definitely indicative of a problem. The spectral data is dominated with cage and many harmonics. This is a NSK NU 318 bearing which has 13 rolling elements.

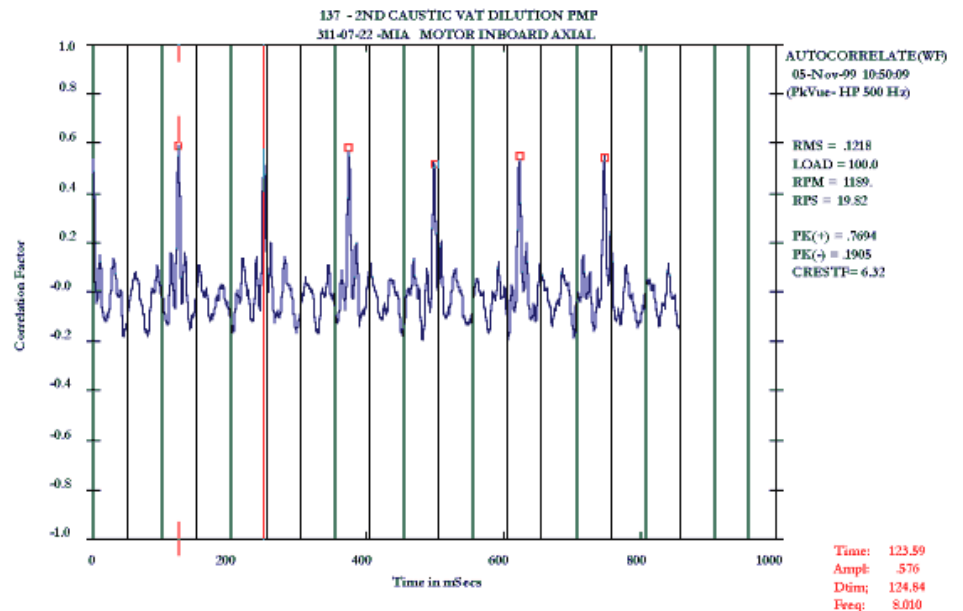
The autocorrelation coefficient data computed from the PeakVue time waveform are presented in Fig. 18. The only significant activity is the cage activity.

Figure 18. Autocorrelation coefficient from PeakVue time waveform of Figure 17.

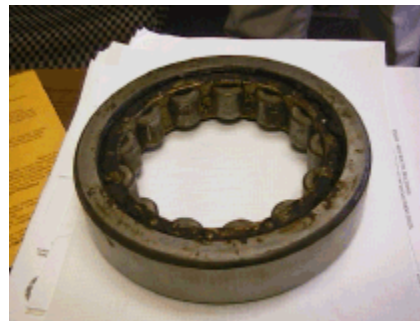
A photo of the defective bearing is presented in Fig. 19. The rolling elements show indication of "skidding," but the dominant problem is the "caked" residue of lubricant (grease).

Figure 19. Photography of the defective bearing highlighting the "caked" residue of lubricant and skid of roller 5.

This bearing is being replaced with a rolling ball element bearing. The problem of grease being "pushed out" is not uncommon with cylindrical rollers in low radial load applications.
