# Predict Service Life of Actuator Diaphragms?

## NOW YOU CAN

BY PAUL GASSMAN & TED GRAUBAU

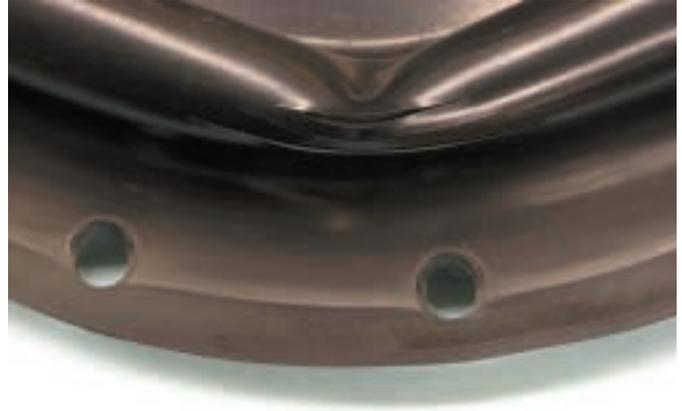
Figure 1: Oxidation cracking typical of exposure to high temperature or extremely long service at normal application temperatures. This is the predominant failure mode of a diaphragm at the extreme limit of polymer aging.

Ultraviolet light that falls directly on the rubber surface affects a chemical reaction between the oxygen in air and the unsaturated (double) carbon=carbon bonds in the polymer chain. This causes a scission of the carbon “backbone” of the polymer, resulting in a crack. Continued exposure to UV light allows the crack to progress further into the material. Such cracks appear as crazing with an orientation that is normal (90°) to the tensile stress. (**Figure 1**) This is the kind of damage usually termed “weather checking” and visually matches that often found on the sidewall of tires.

Oxidation is a chemical process that has a rate of reaction that is exponentially related to temperature. As such, a relatively short exposure of a diaphragm to high temperature can impart the same amount of damage that normally would take years to accumulate at ambient temperatures. If compression set resistance is marginal, over-temperature can cause a loss of flange retention. If compression set is robust, over-temperature ultimately will oxidize the rubber coatings on the diaphragm. The coatings will become brittle and then crack during stroking. These cracks typically are large compared to ozone/UV damage and allow loss of air pressure through the thickness of the diaphragm and/or to the fabric. The air pressure can wick to diaphragm perimeter and leak to the atmosphere.

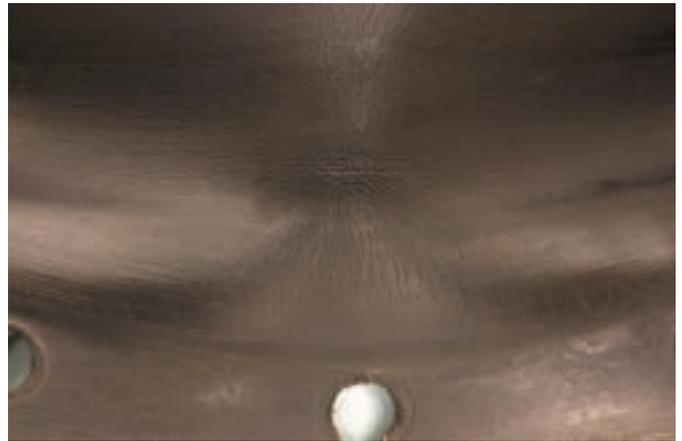
Figure 2: A Nitrile test specimen after 24-hour exposure to 300 ppb ozone. Notice how the crazing is generally normal to the direction of the applied tensile stress imposed by bending. Also, the crazing is so small that it is unnoticeable until the specimen is flexed to open the small cracks. Contrast the size and population of these cracks with the oxidation cracks depicted in Figure 1.

Ozone ( $O_3$ ) imparts the same sort of damage to elastomers. (Figure 2) In fact, some researchers believe that UV impingement on a rubber surface actually generates ozone locally from the atmosphere, and that the polymer damage is actually from the reaction with ozone.

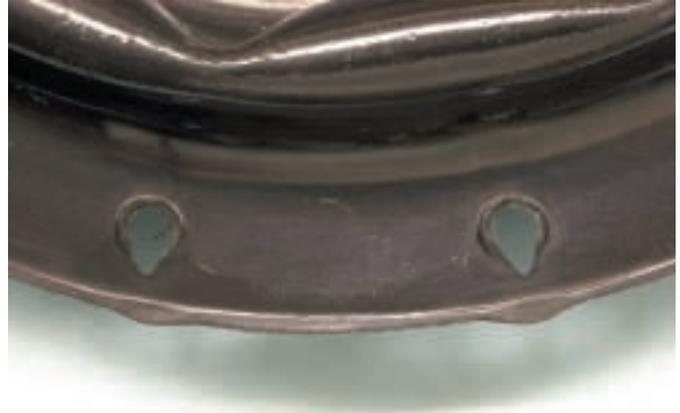
*Figure 3: Typical teardrop shaped bolt holes due to loss of retention (compression set of the diaphragm) and stretching. Notice also the scallop shapes outside each bolt hole and the ledges of displaced rubber both inside and outside the flange.*

Excessive clamping typically creates a ledge of rubber just inside of the flange faces, a scalloped appearance of the diaphragm extruding outside the diaphragm case, and delamination of the rubber from the fabric. Distortion of the bolt holes also can occur with a resulting loss of seal integrity.

Other factors that affect performance in this regard are the thickness of the diaphragm, rubber/fabric volume ratio, and adhesion to the casing flange surfaces. Loss of retention results in stretched, teardrop shaped bolt holes (Figure 3) and eventual loss of the flange seal.

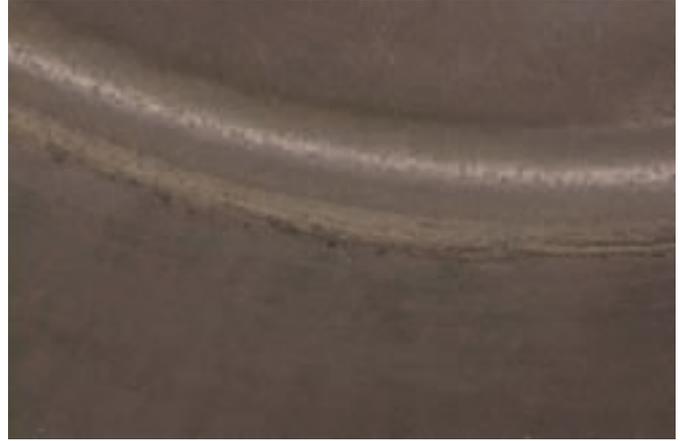
Figure 5: A diaphragm coated with rubber on both sides of the fabric and cycle tested similarly to Figure 4. Even after one million full pressure cycles, only some rubber crumb is visible from abrading the edge of the diaphragm plate, and the fabric is still protected.

OEM’s concerned about reliability usually coat both sides of the diaphragm with rubber to protect the fabric from abrasion. While rubber coating is only required on the pressure side of the diaphragm to function, the rubber coating on the side facing the diaphragm plate vastly improves cycle life.

**(Figure 5)** In fact, the cycle life of the diaphragm can exceed that of return springs as well as the diaphragm cases. This is a typical benchmark test for actuator diaphragms.
