# Predictive maintenance

by Wael A Labib,  
Cemex, Egypt

Modern predictive maintenance techniques and the use of a patented method of viewing vibration measurements were combined to identify a potentially crippling bearing fault on Cement Mill 7 at the Cemex plant in Egypt, avoiding unplanned downtime that could have cost as much as US\$510,000. If the faulty bearing had not been discovered in time, it might have seized up, causing an emergency shutdown of the mill. A two-day stoppage for repairs would have resulted in a product loss of 4600t at an average price of US\$100/t, plus US\$50,000 for repair parts. The cost could have been much greater if a sudden bearing failure resulted in pinion gear and shaft damage as well.

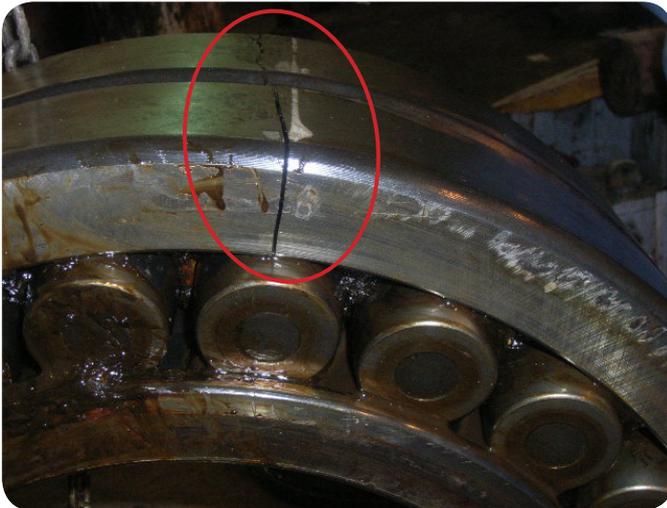
Figure 2: confirmation appears on subsequent axial views of the inboard pinion bearing

This identification using conventional vibration data occurred considerably later than the initial revelation of the problem by PeakVue. Note that the vibrations returned to normal on 3 June after the repair completed on 1 June.

Once it was established on 20 April that a bearing fault existed, the location had to be found and the severity of the problem determined. By checking the fault frequencies, the outer race of bearing 23168B was pinpointed. Confirmation appeared in subsequent axial views of the inboard pinion bearing from readings taken on 5, 18, and 19 May (Figure 2).

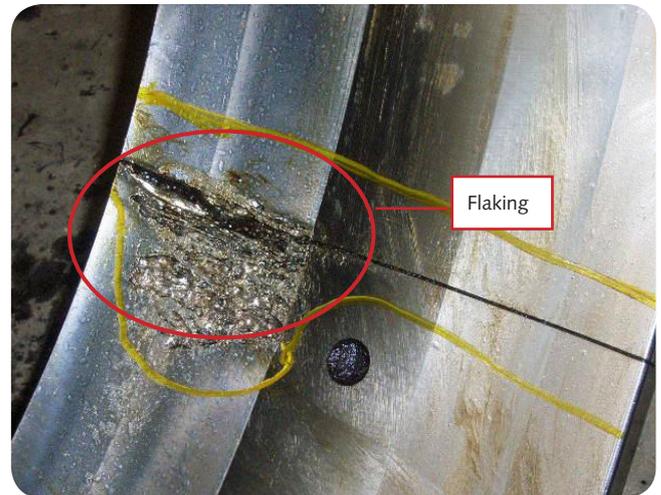
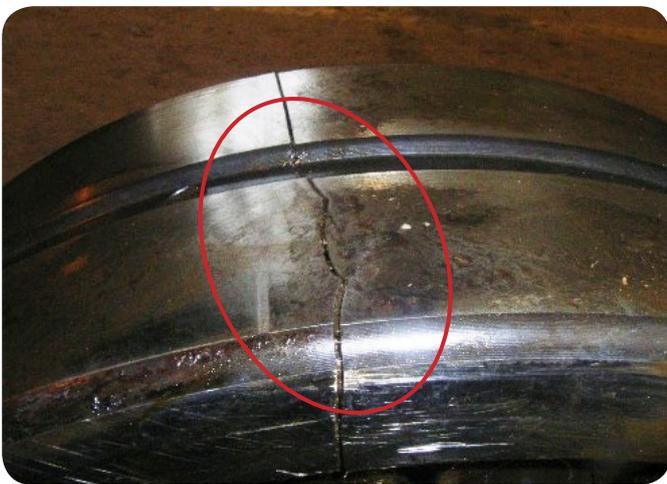
Analysis proved to be correct when the bearing was removed and inspected. The outer race was cracked, and flaking had begun

The analysis proved to be correct when the bearing was removed and inspected. The outer race was cracked, and flaking had begun, as shown in the pictures above. It was only a matter of time before this part failed due to high stress during normal operation of the mill.

Based on the accumulated information indicating the apparent severity of the problem, a decision was made to stop the mill for repairs, precluding a sudden failure while running that might have caused pinion shaft damage.

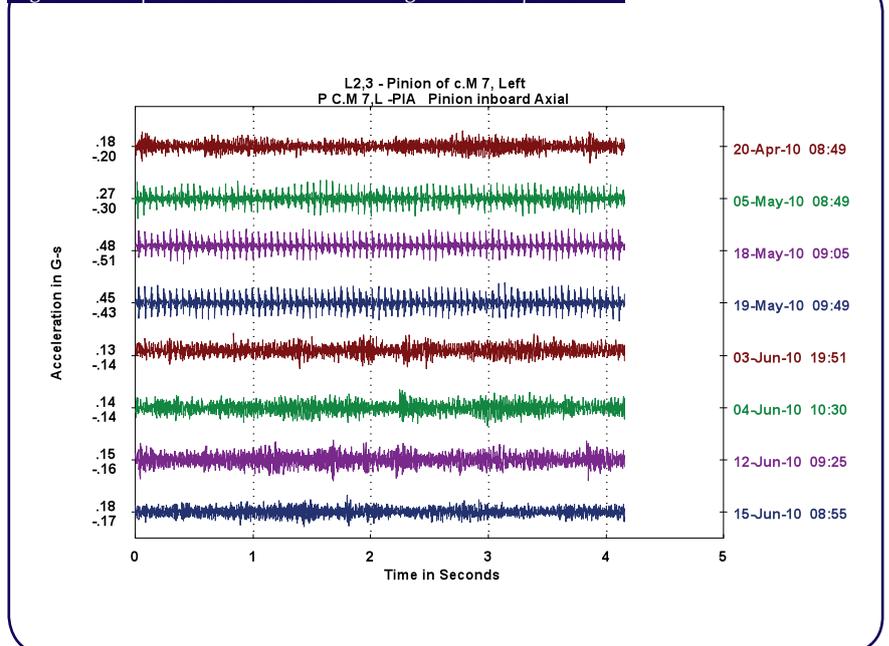
Figure 3: multiple waveform views confirm significance of problem

Multiple waveform views (Figure 3) confirmed the significance of the problem on 5, 18 and 19 May – also returning to normal on June 3.
