# Emerson's Condition Monitoring Solution helps Arabian Cement Company protect its critical assets and prevent 70,000-ton production loss

Online Machinery Health Monitoring of a gearbox in a horizontal ball mill.

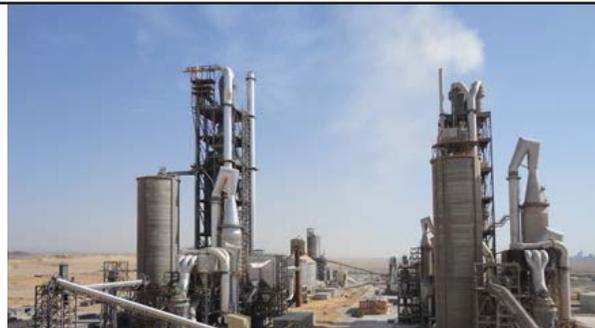
*Emerson’s Online Machinery Health Monitoring solution monitored the condition of a fracture in the gearbox’s bearings’ cage allowing safe production for 17 days.*

The ACC plant operates four horizontal ball mills that are driven by a 6-megawatt gearbox, helping to produce 185 tons of cement per hour for each mill. In December 2014, the plant team detected a sudden increase in the vibration levels of the gearbox, and consequently by inspection discovered a fracture in one of the gearbox's bearings.

The cement mill had a smooth and safe production for 17 consecutive days, until the online monitoring began to detect a condition that went against the running parameters set for the equipment. Consequently, Emerson was consulted by the plant team and the team was advised to stop the mill for inspection, which revealed that they had a complete failure of the bearing cage. Accordingly the mill was stopped for repair in order to prevent any further failure or damage. The repair was carried out and the mill was back in steady operation with full capacity in January 2015.
