Absolute Energy LLC Increases Plant Availability and Reduces Energy Costs with Reliable Guided Wave Radar

Water levels in condensate receiver for sieve dehydration process

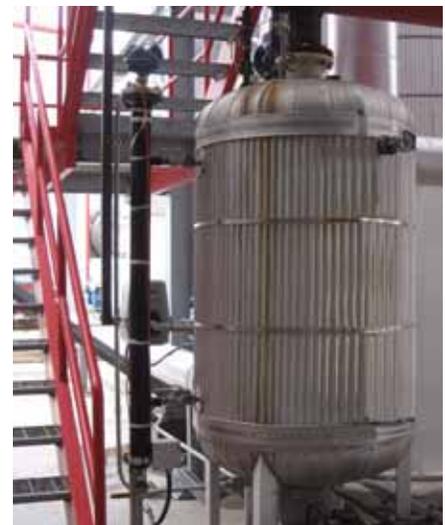
Figure 1: Rosemount 5301 Guided Wave Radars mounted on Rosemount 9901 chamber for condensate receiver level control.

To address these challenges, Absolute Energy installed a Rosemount 5301 Guided Wave Radar (GWR) combined with the Rosemount 9901 Chamber. As a single point solution, it was mounted on the existing process connections. GWR technology is not dependent on density changes and manages changing pressure conditions without compromising the reliability.

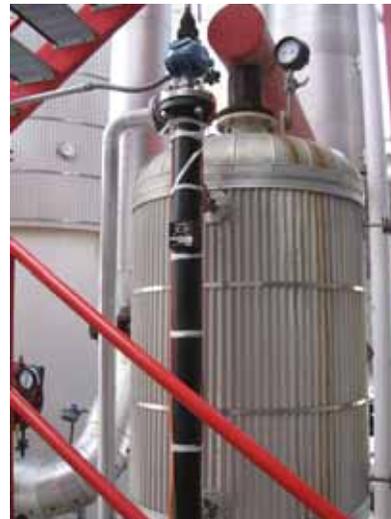
Figure 2: This is the 3-in. diameter Rosemount 9901 Chamber prior to adding insulation.

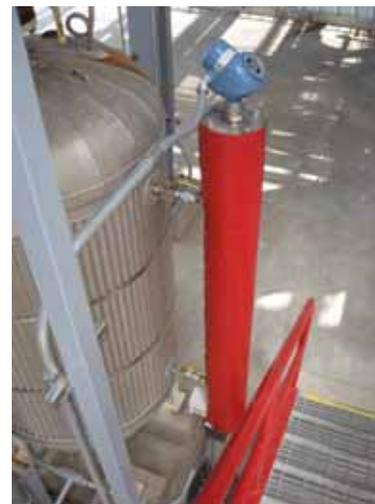
Figure 3: Rosemount 5301 (GWR) with Rosemount 9901 Chamber.
