Impact Detection

Cutting Through the Complexity of Machinery Analysis

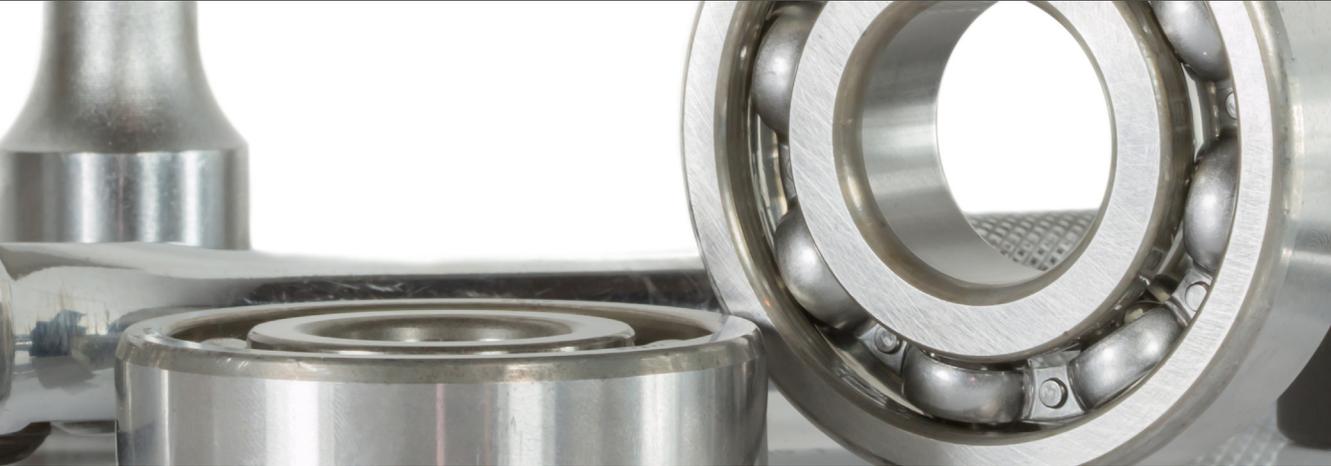
The PeakVue trend provides operators with a simple yet conclusive way to verify when a machine is in good condition and provides early warning of developing problems with an indication of severity.

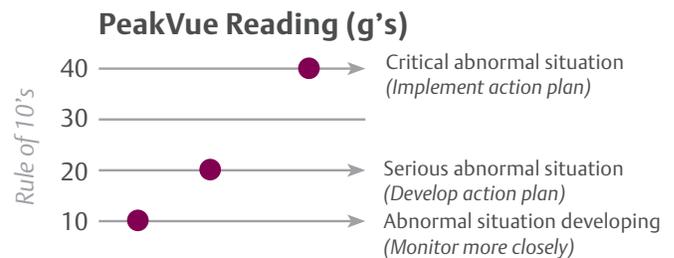
As common machinery faults begin to appear on rotating equipment (e.g. rolling element bearing defects, gear defects, insufficient lubrication, or pump cavitation), the PeakVue reading typically can be evaluated using the Rule of 10's:

As a measure of impacting, PeakVue readings are much easier to interpret. A good machine, properly installed and well lubricated, should normally not have any impacting on it. This establishes the zero principle:

The PeakVue measurement on a good machine should be at or close to zero.

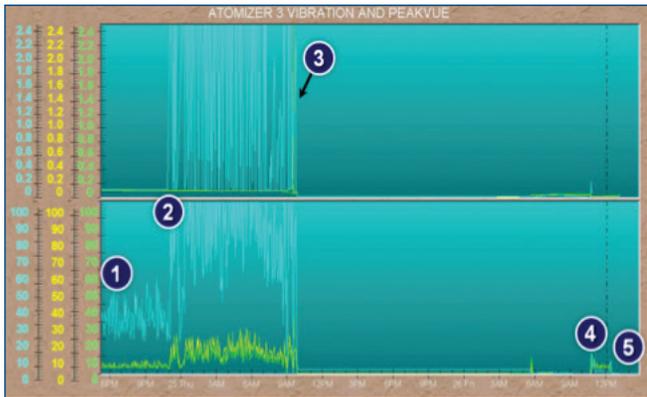
The PeakVue trend makes it possible for operators to discern machine health without any specialized training.

The power plant installed an Emerson transmitter on the atomizer and included PeakVue technology. At the point of start-up indicated in the graph (area 1), the overall vibration readings (indicated by green line) were all below acceptable levels. In contrast, the PeakVue readings on one bearing (blue line) were already ranging from 30 to 40 g's—indicating that a critical bearing fault was likely already in play.

Six hours later, around midnight, the vibration at this bearing location (area 2 of graph) shifted dramatically. The PeakVue levels rose sharply to above 100 g's, while the overall vibration level jumped suddenly from baseline to nearly ten times the fail-alert level. Both of these changes indicated that the bearing was in the process of failing. The control room communicated with maintenance planning to schedule maintenance for the following morning and continued to monitor the machine closely.

By about 9 am, the overall vibration level (area 3 of graph) on an adjacent bearing suddenly increased sharply from baseline level to about ten times the fail-alert level. At this point, operations made an immediate call to shut down the process.

The defective bearing was replaced, and the machine was scheduled for start-up the following morning (area 4). The operator, familiar with PeakVue's Zero Principle, noted that the machine was running at nearly 10 g's at start-up. He contacted maintenance and asked them to check out the machine. As a result of the PeakVue warning and the operator's prompting, the maintenance team discovered the root cause of the repeated failures on this machine: the grease fitting was clogged. As a result, when they lubricated the bearing, only a fraction of the grease actually made it to the bearing.

The maintenance team cleaned the grease fitting, reapplied lubrication, and as expected, the PeakVue readings dropped below 1 g (area 5). The same asset that had previously failed every three months for more than a year has now been running for more than two years without incident.
