# Machinery Asset Monitoring Breakthrough: How a Five-Site Rollout Sparked Enterprise-Wide Reliability Gains and ROI

# Global Building Products Manufacturer Deploys AMS Solutions Across Multiple Manufacturing Sites, Realizes Savings Approaching \$700K in First 12 Months

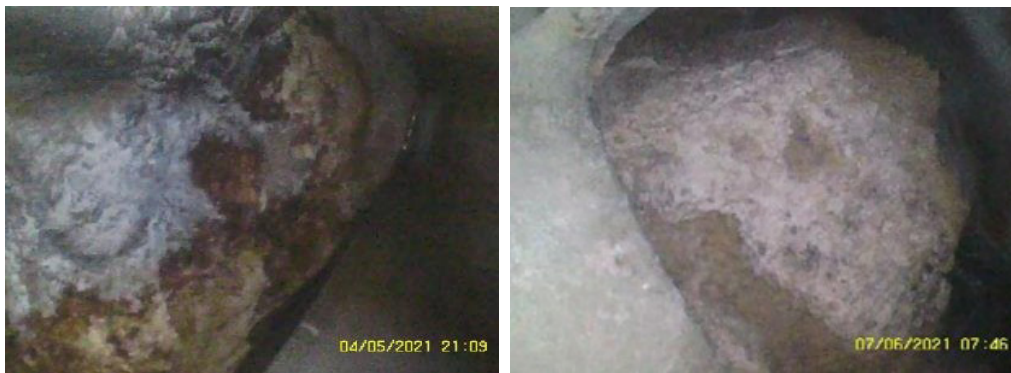
*Calcium deposition is a recurring issue with these pumps, requiring weekly acid flushes to keep pump internals clean.*
