Offshore Oil Producer Minimized Risk of Reduced Production and Well Availability with Non-intrusive Temperature Measurement

Flowline Temperature Monitoring

Oil producer in Thailand

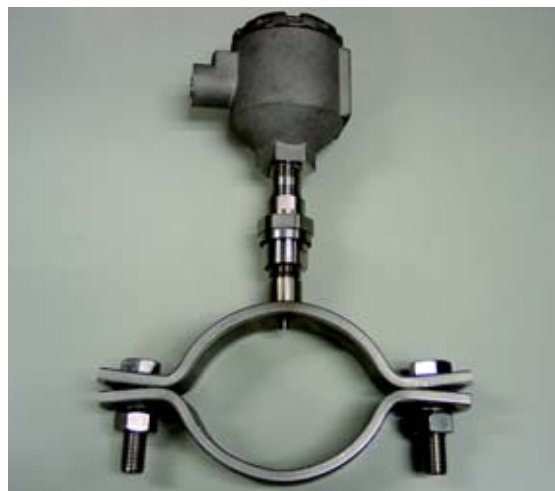
The Rosemount 644 Temperature Transmitter used in conjunction with the Pipe Clamp RTD Sensor design

The offshore oil producer reduced the possibility of paraffin buildup by installing customized Rosemount Application and Industry Solution (AIS) Sensors, which incorporated a non-intrusive pipe clamp sensor design. The non-intrusive design eliminates insertion into the process, and is quickly installed on the external piping.

The Rosemount 644 Temperature Transmitter, used in conjunction with the Pipe Clamp RTD Sensor design, enabled the customer to quickly install temperature measurements in areas where paraffin buildup was common. The temperature measurements helped the customer to be proactive, and reduce paraffin buildup within the production flowlines.

The Rosemount 644 Temperature Transmitter with Pipe Clamp RTD Sensor design allowed this customer to detect paraffin buildup, saving operations and maintenance costs.
