Remote Mount Display & Interface capability enables optimal separator measurement

Rosemount 3051S Pressure Transmitters with Direct Mount 1199 FFW Seals and Remote Mount LCD Display & Interface

Level measurement on coalescer filter separator

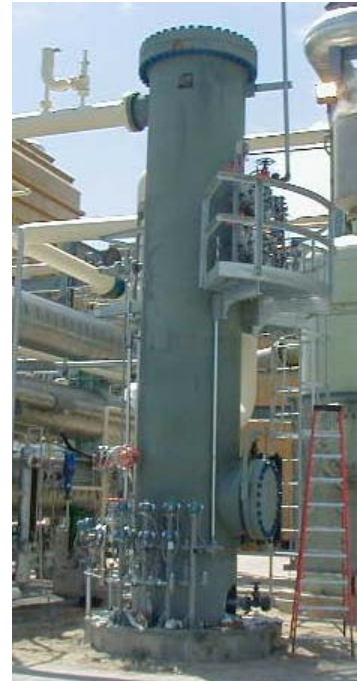
Rosemount 3051S

- Three 3051S pressure transmitters with direct mount flush flanged seals installed at the very bottom of the separator to measure level in the collection chamber. A redundancy voting scheme (2 out of 3 must agree) would be utilized as an added safety precaution.
- One 3051S differential pressure transmitter with dual flush flanged seals installed across the filter to identify clogging (rising differential pressure indicates the filter is clogging.)
- Three 3051S pressure transmitters with direct mount seals installed several feet from the bottom of the separator to measure the level of the coalescing filter (2 out of 3 must agree voting scheme).

Remote mount LCD display and interface on all seven transmitters for local indication at grade and ease-of-use for instrument technicians.

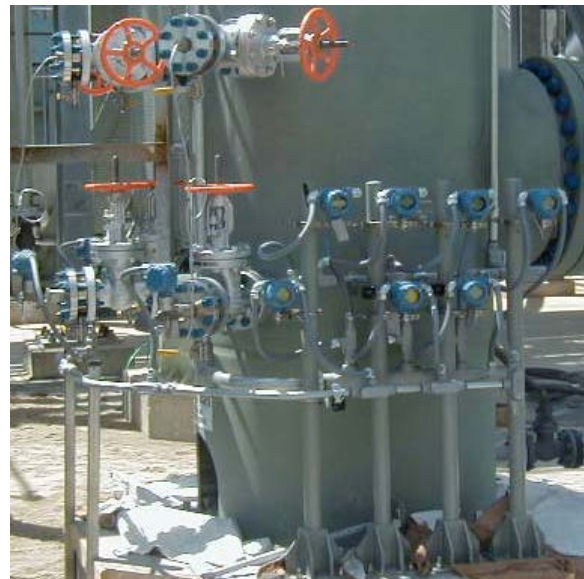
The new 3051S remote mount LCD display & interface capability allowed the customer to:

- Eliminate the capillary runs.
- Bring local indication at grade.
- Access all transmitter functions at grade.

Direct mount FFW seals with 3051S Ultra performance and remote mount LCD display & interface provided the optimal solution. Separator level is now being properly controlled and future occurrences of turbine damage due to level excursions are highly unlikely.
