Cooling Tower Monitoring

Wireless Vibration Monitoring for Motor and Gearbox Combinations

SIMPLIFYING VIBRATION MONITORING OF A COOLING TOWER FAN

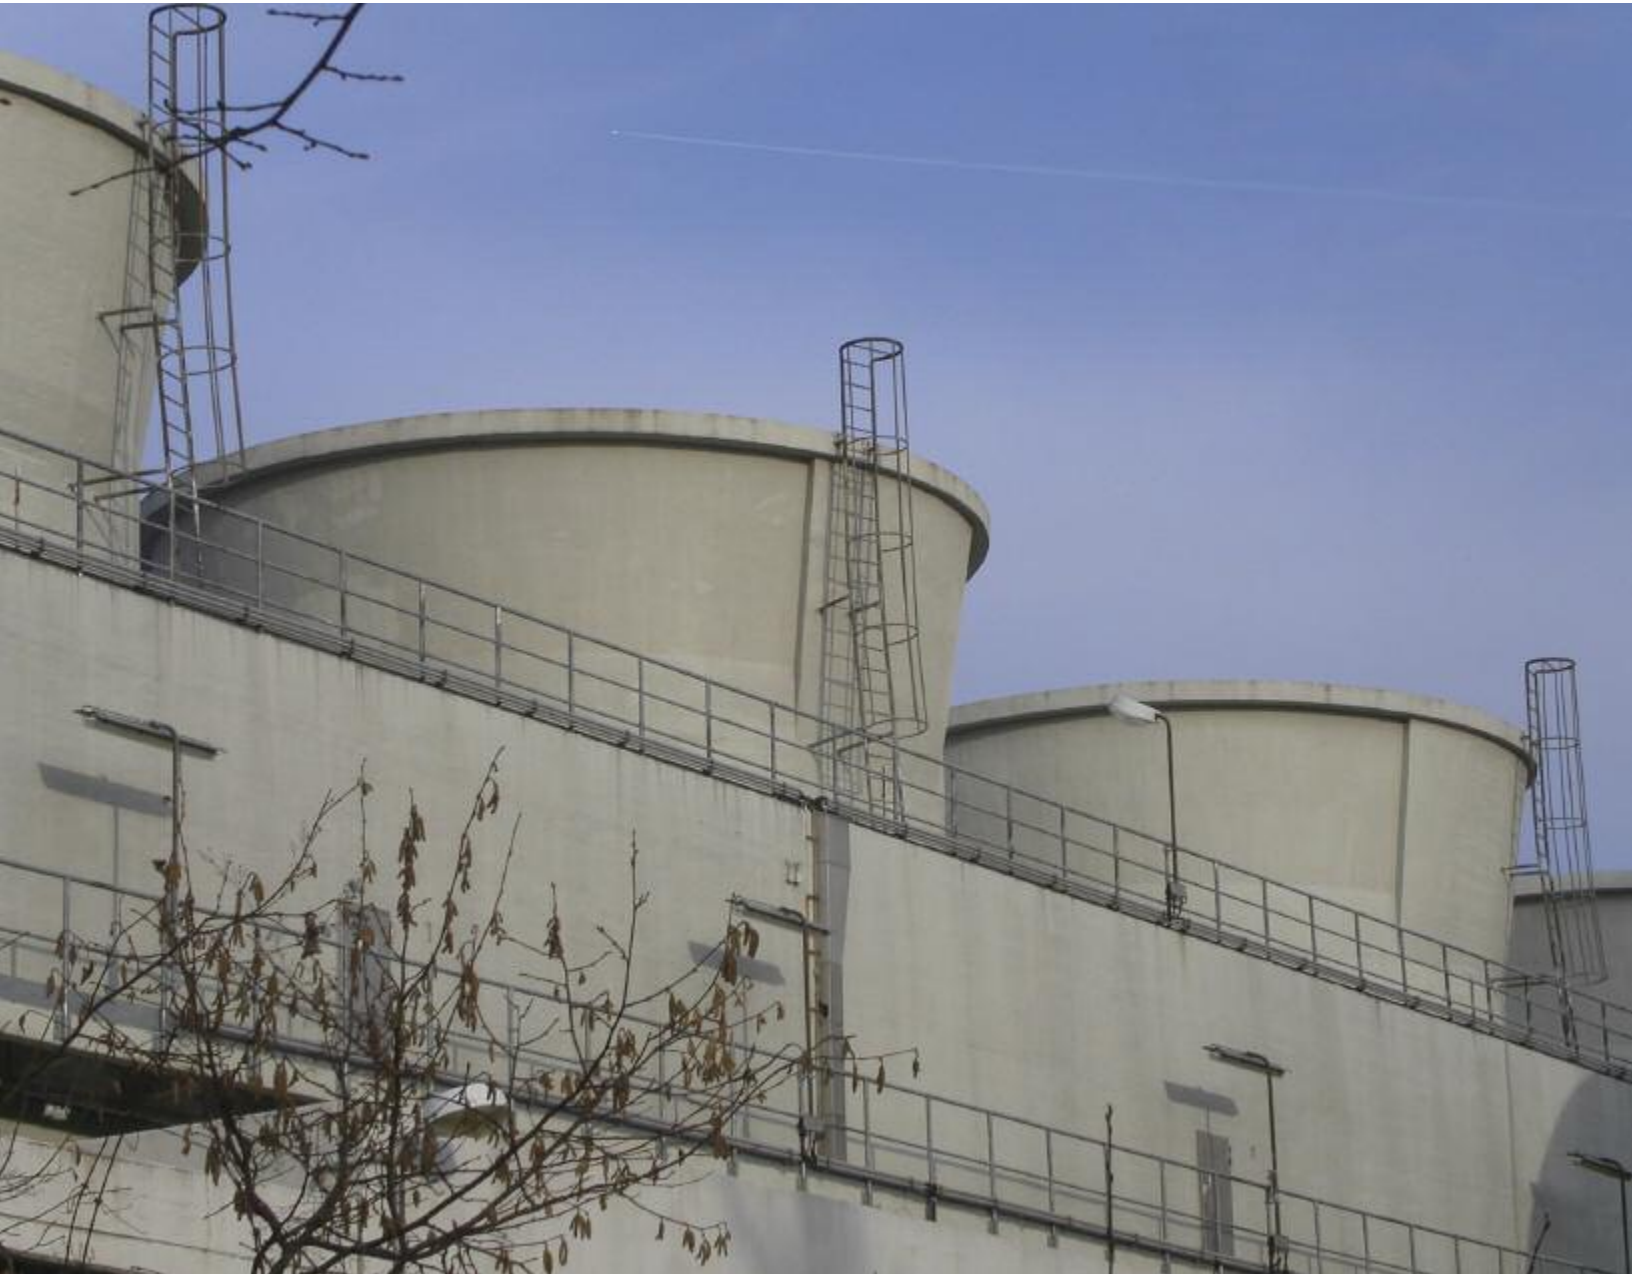
Cooling tower fans operate under different load conditions. They often only run at peak load for short periods. With differing stresses over a prolonged period, the mechanical components can develop degraded performance, which leads to failure. As with any rotating equipment, bearing and gear failures, misaligned drive shafts, and excessive vibration are common.

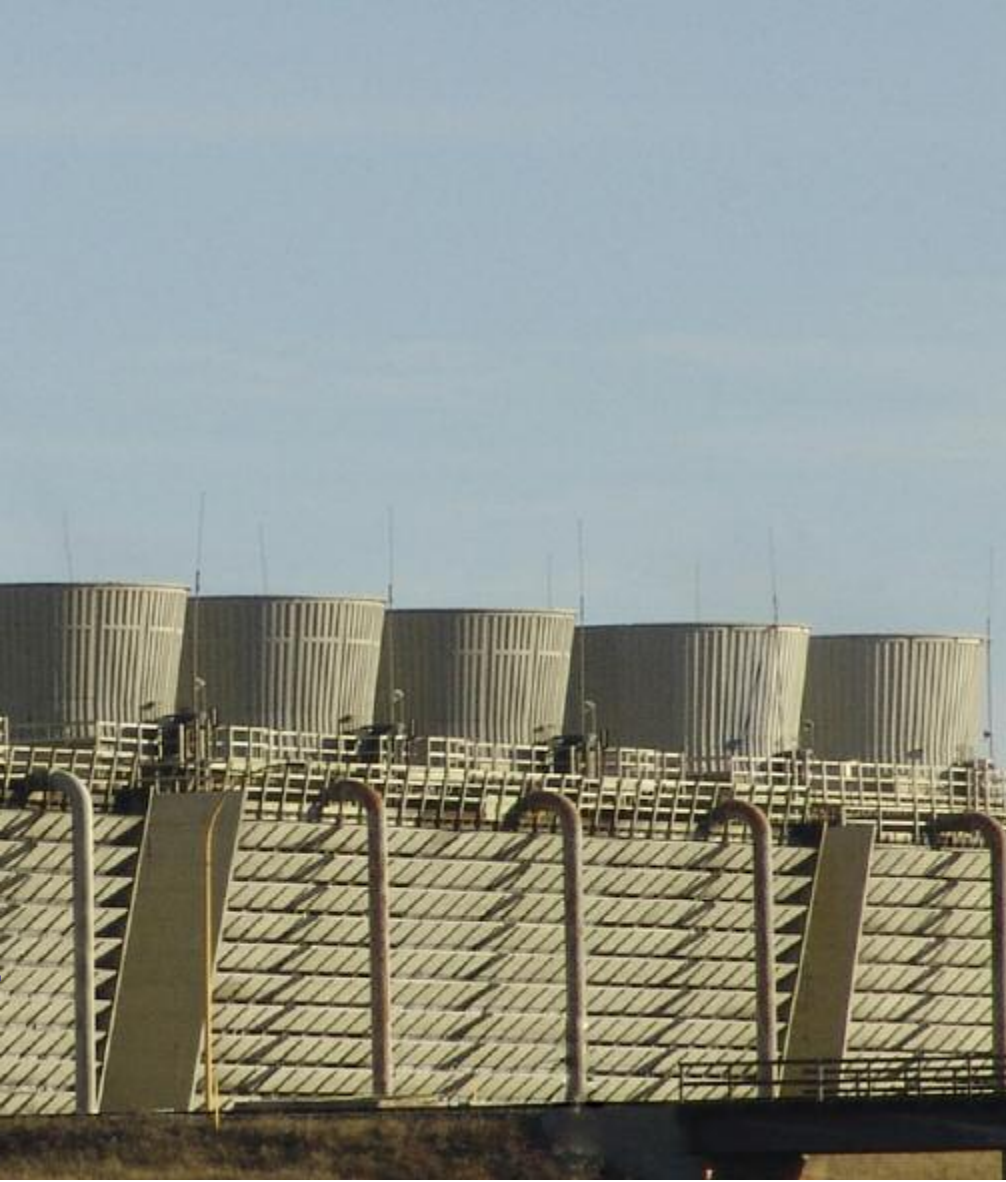
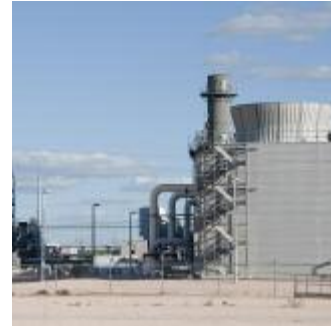
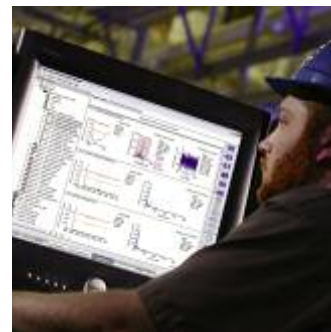
The structure of a cooling tower makes collecting vibration data on the gearbox difficult and dangerous without permanently installed sensors. Because the gearbox is a typical failure point, lack of feedback on the machine's health puts you at risk for unexpected failure.

As part of Emerson's Smart Wireless solution, the CSI 9420 Wireless Vibration Transmitter provides insight into the health of cooling tower gearboxes and motors. Vibration alerts warn of pending problems, enabling further investigation to detect and diagnose the fault so maintenance can be scheduled.

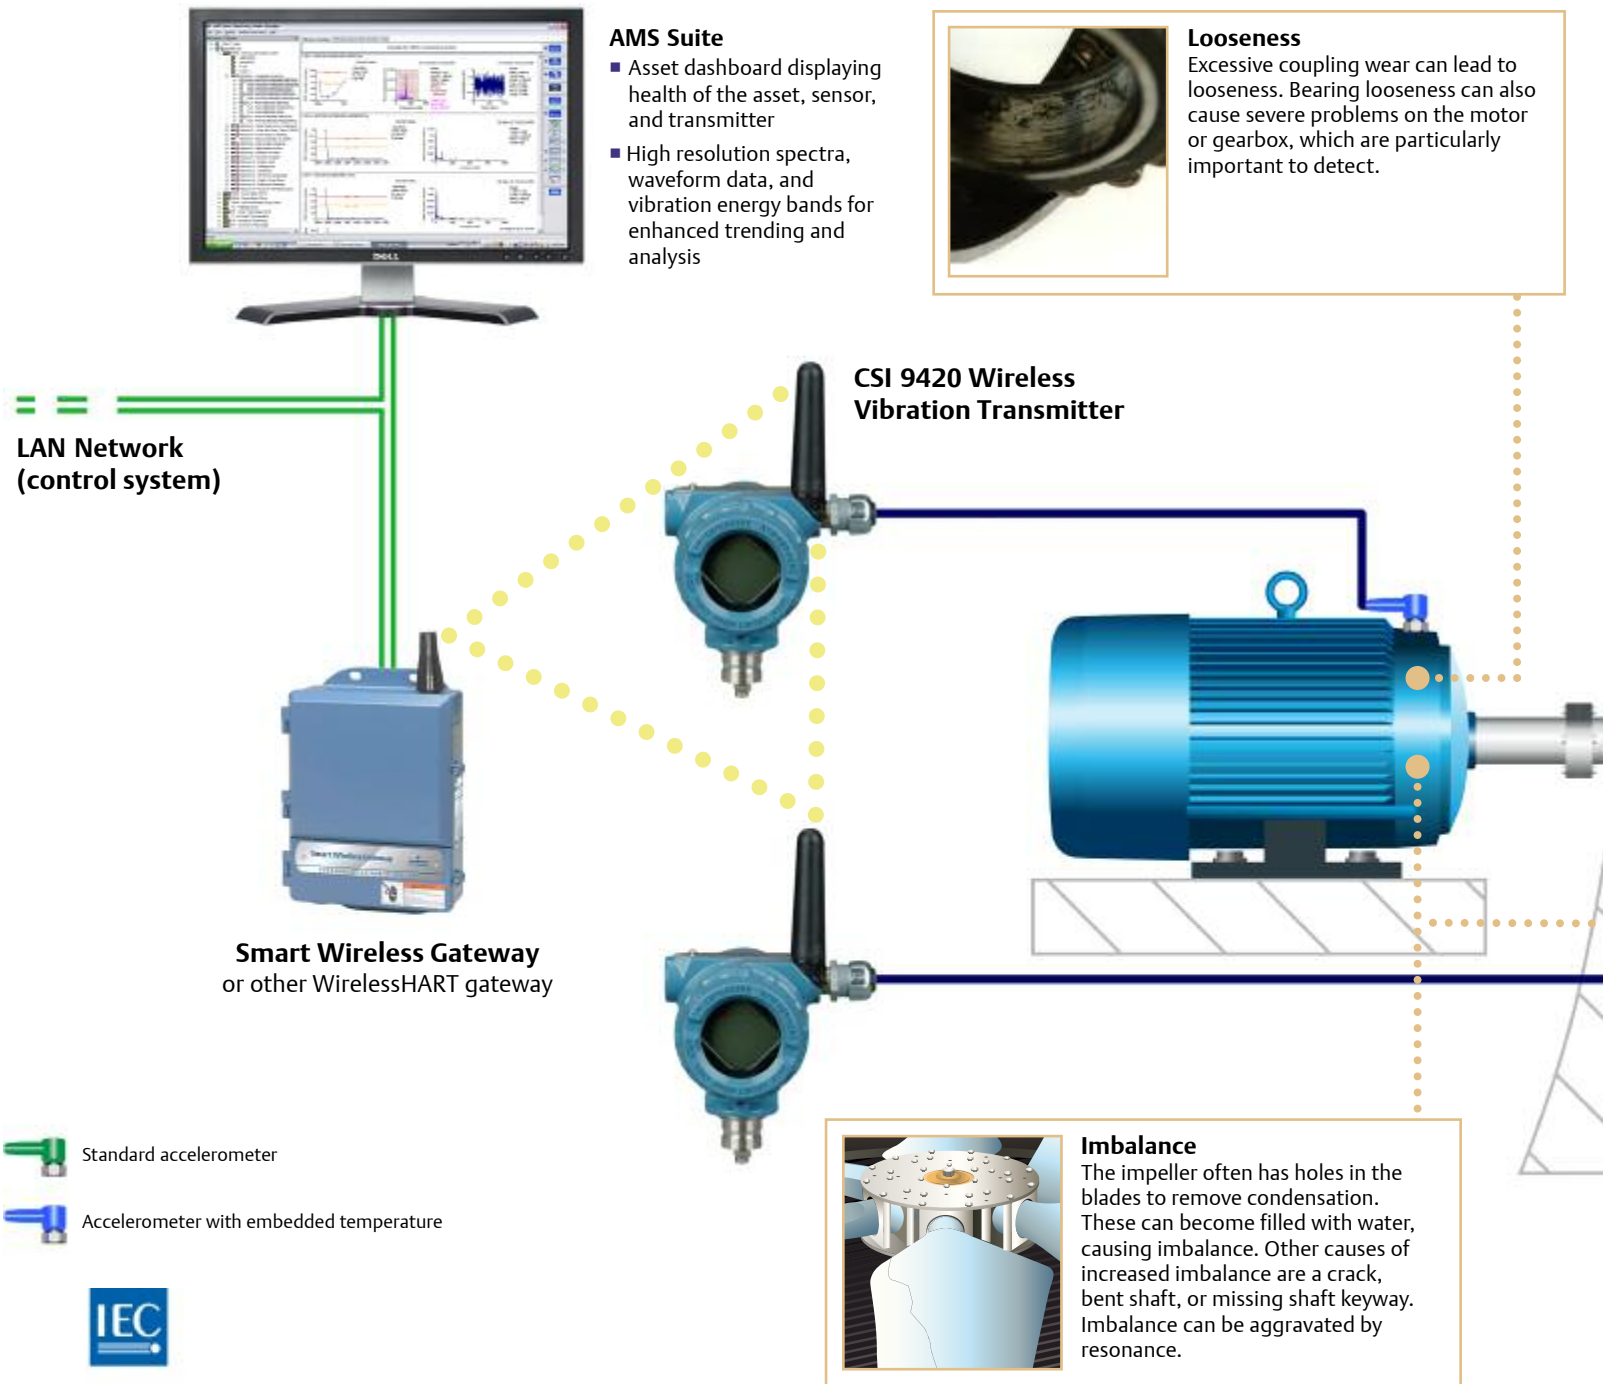
The CSI 9420 delivers insight on the health and performance of previously inaccessible cooling tower gearboxes and motors. Vibration diagnostic data allows reliability specialists to analyze and troubleshoot developing issues.

All of these problems can be detected and diagnosed in AMS Suite.

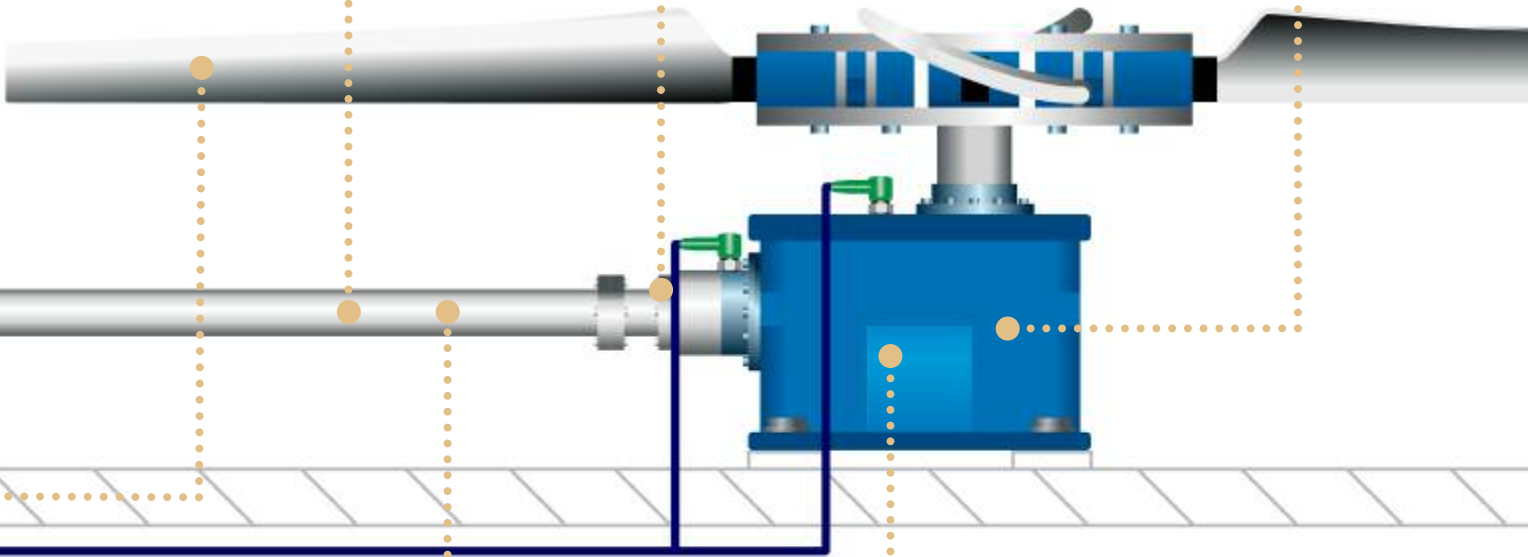
Broken/Chipped/Worn Teeth

Shaft misalignment causes increased load on the input gear, which causes bad meshing of the gears and generates debris. Damaged and misaligned gears can result in failure of the gearbox.

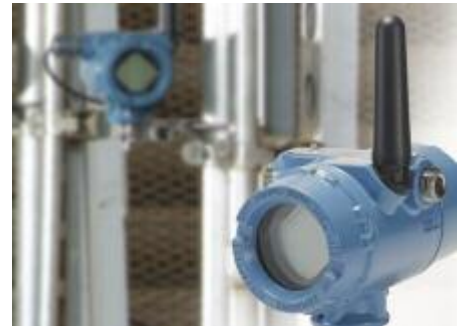
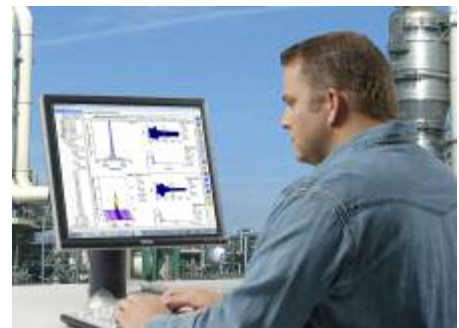
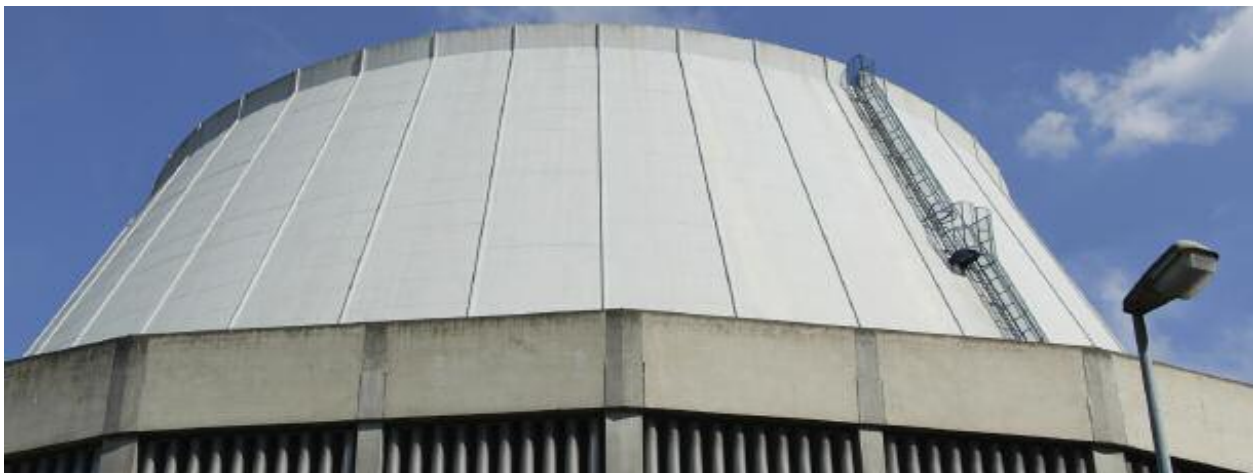
The asset dashboard in AMS Suite displays the health of the sensor, the transmitter, and the motor and gearbox being monitored. In addition, detailed diagnostic data including vibration energy bands and thumbnail spectra are accessible.

The vibration data displayed in AMS Suite provides an indication of imbalance, misalignment, and mechanical looseness. Using PeakVue technology, users can separate stress waves from overall vibration data for accurate early identification of wear on bearings and gearboxes. Together these predictive technologies can identify most common developing mechanical faults.
